# Design variables for steel and aluminium in high-rise rooftops

# **Design Variables for Steel and Aluminium in High-Rise Rooftops**

This dissertation reports a case study in the design and construction solutions for a major corrosion failure of the aluminium louvres and steel brackets on the roof and façade of levels 26-29 of the Westfield Tower 2, Bondi Junction. This work was undertaken during early 2005.

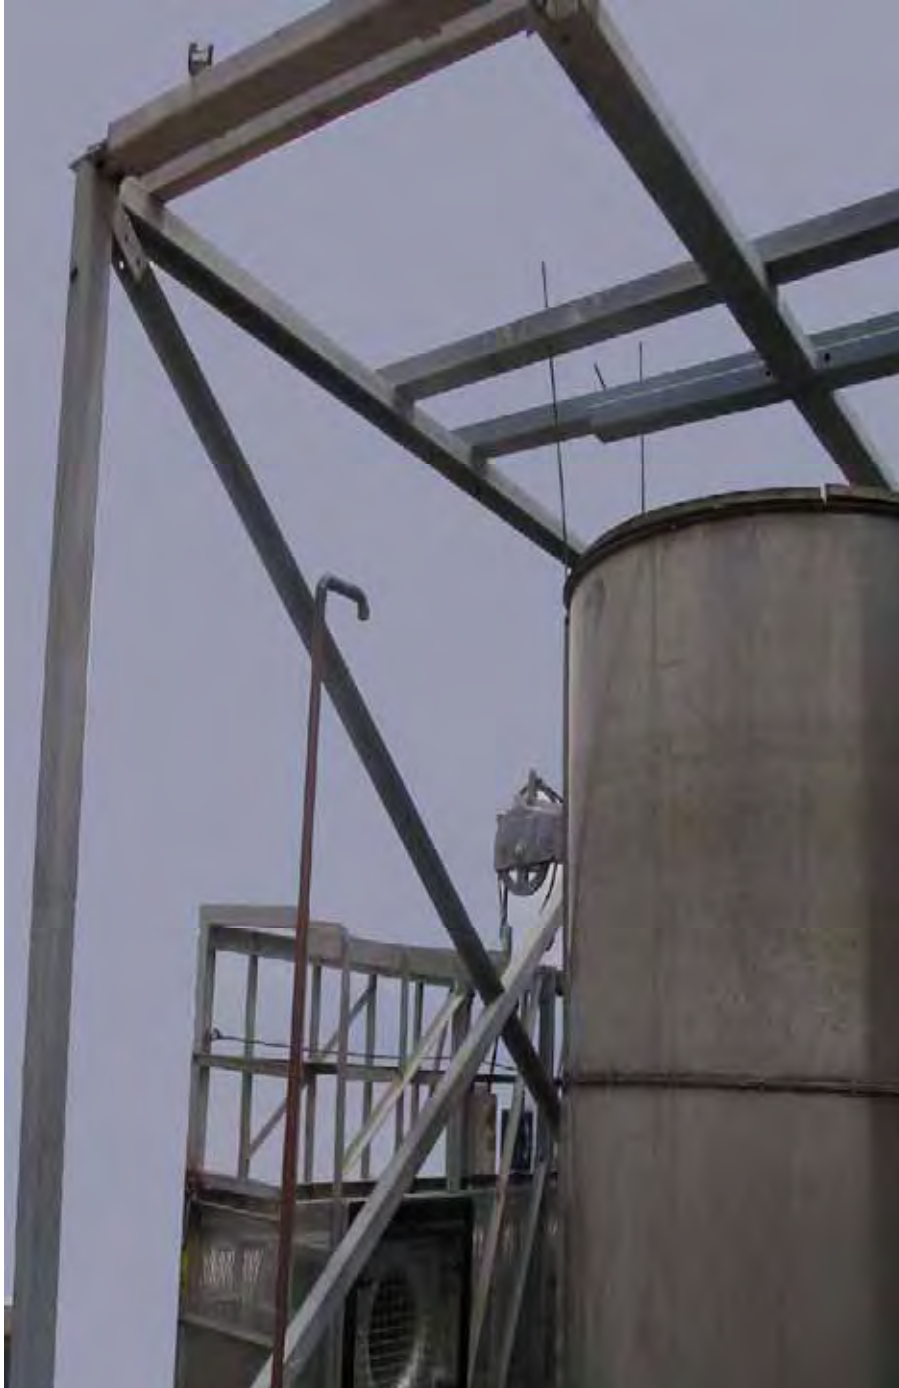
**Figure 4.3** Initial assessment of damaged louvres on southwestern section of Tower 2.

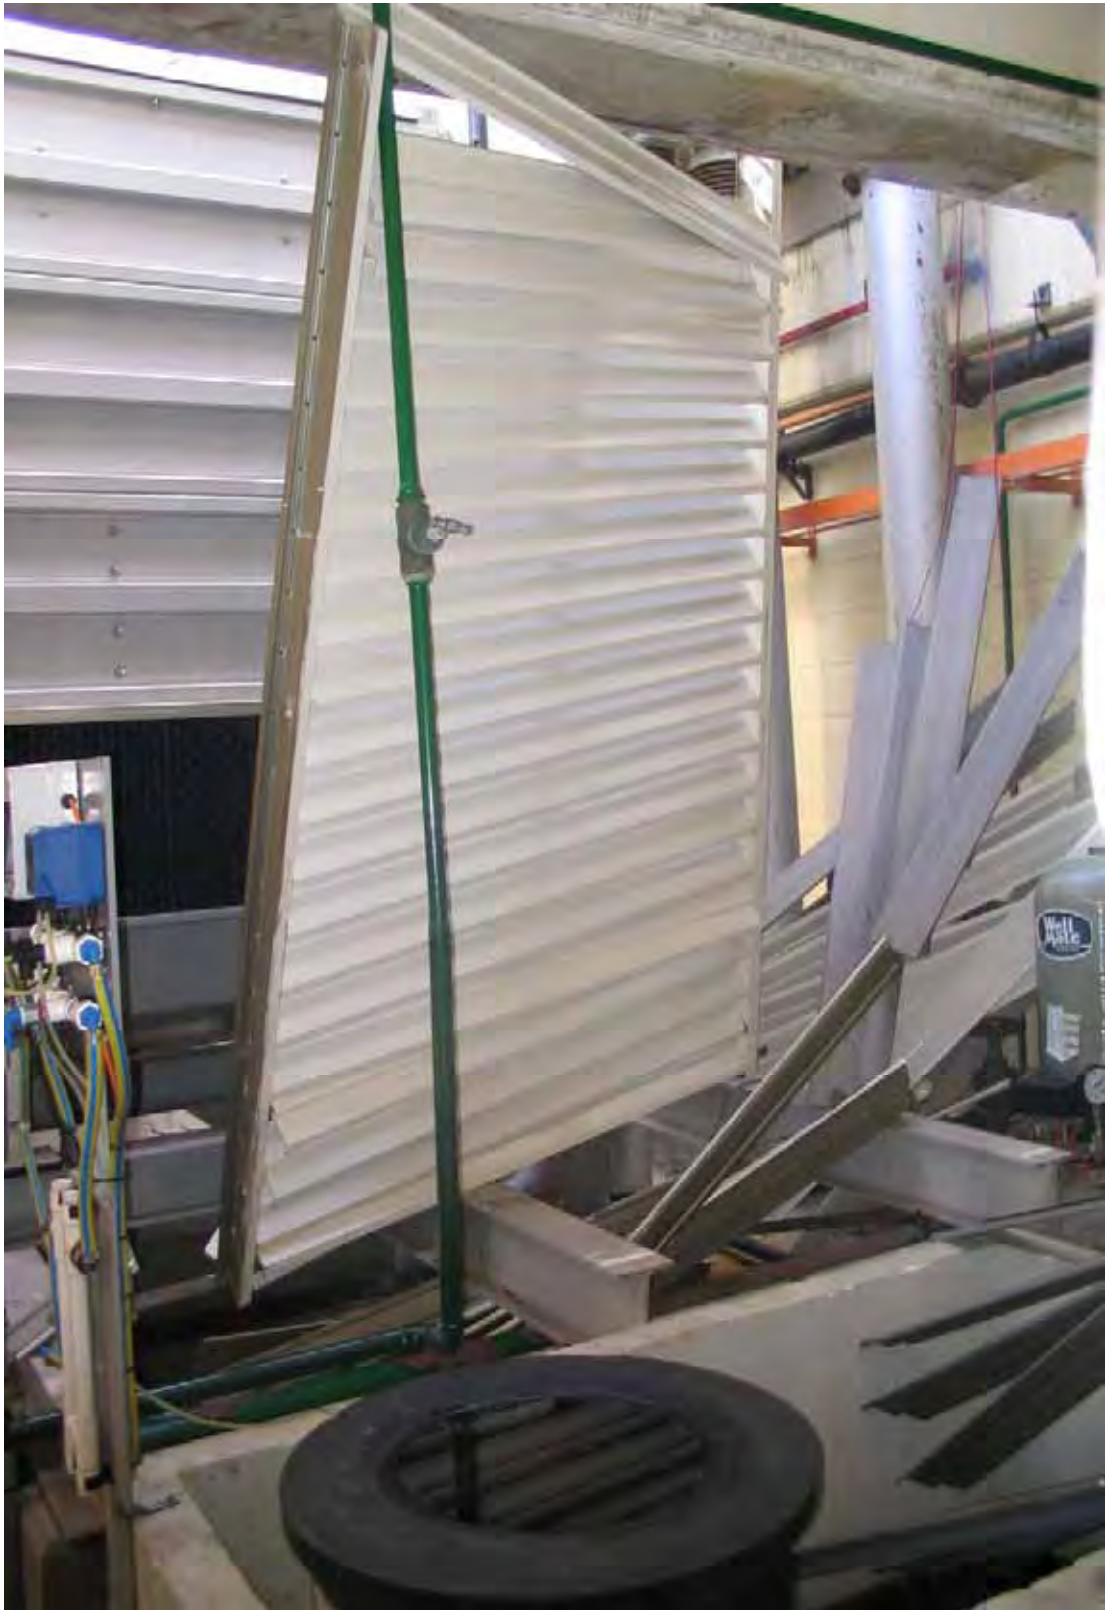
**Figure 4.4** Louvre panels that have detached from structure above and fallen from level 29 down to level 28 in open section.

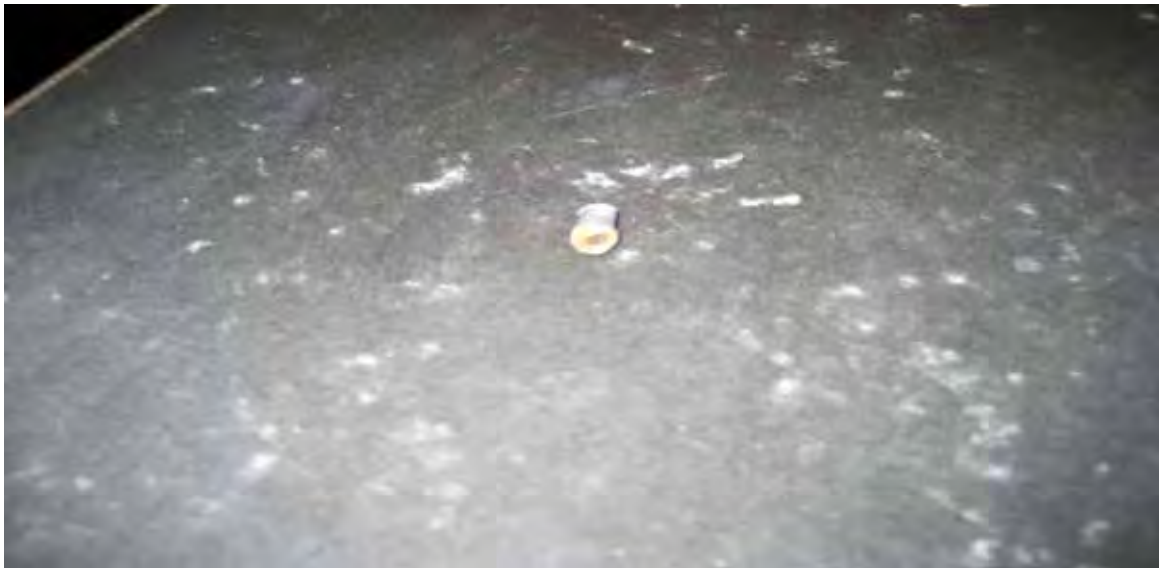
**Figure 4.7** Typically corroded mandrels and pins inside aluminium sleeved rivets that were removed from failed louvre panels on southwestern side of building.

Rivets are manufactured by Huck magna Lok – USA [138 and Appendix M].

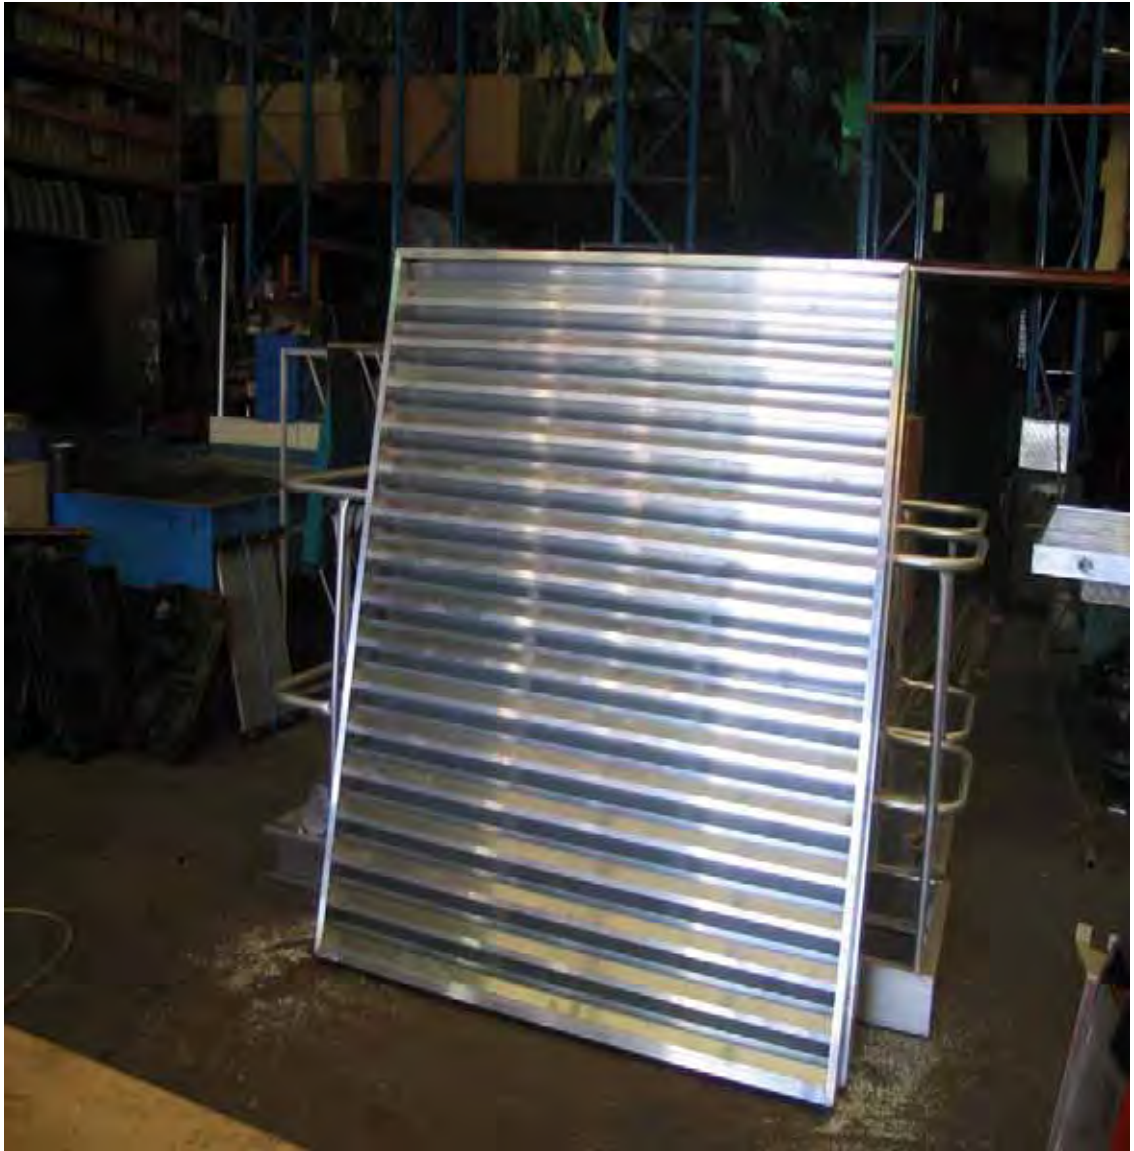
**Figure 4.9** New louvres being manufactured in workshop [Appendix I].

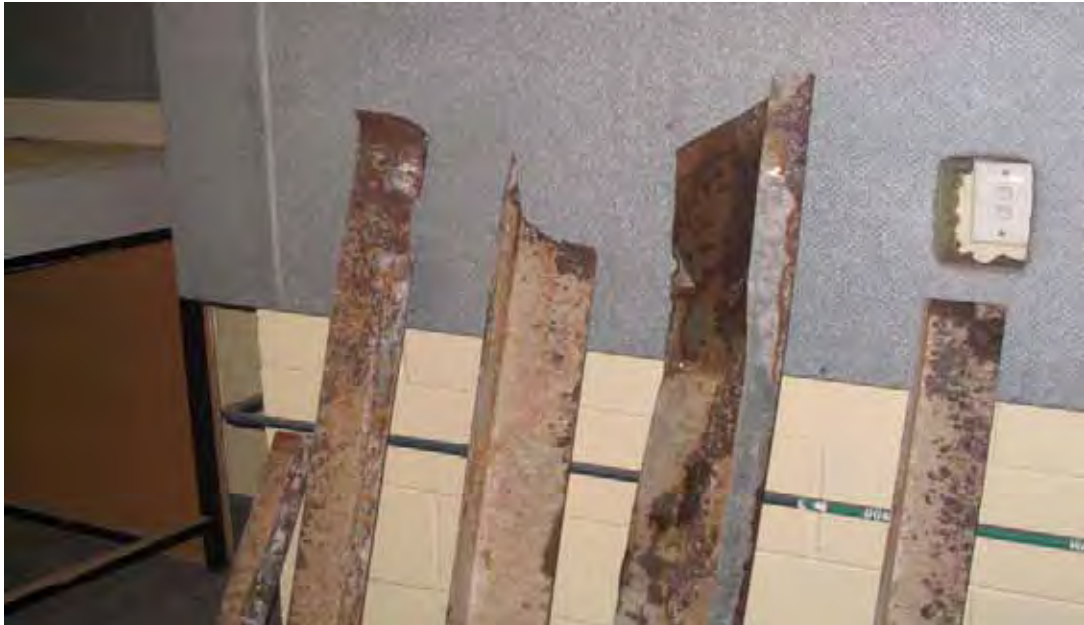
**Figure 4.10** Sheet metal beneath the baffles and enveloping aluminium louvre panels, resulting in crevice corrosion on level 28 at corner of northern section closer to southern side.

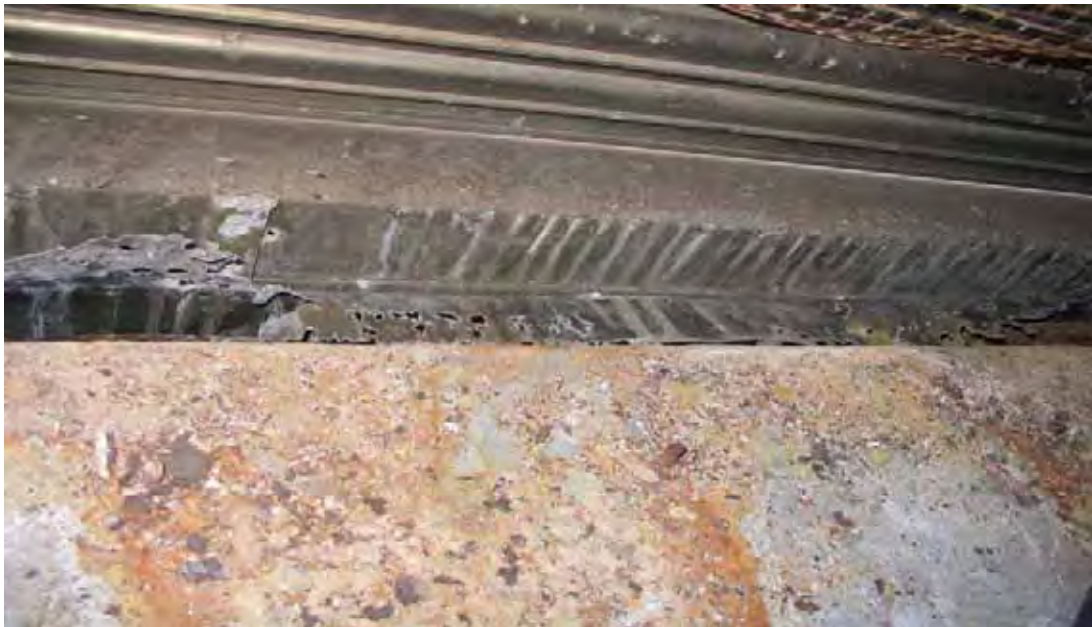
**Figure 4.11** Aluminium panel section showing crevice corrosion and pitting corrosion owing to sheet metal coverage of aluminium.

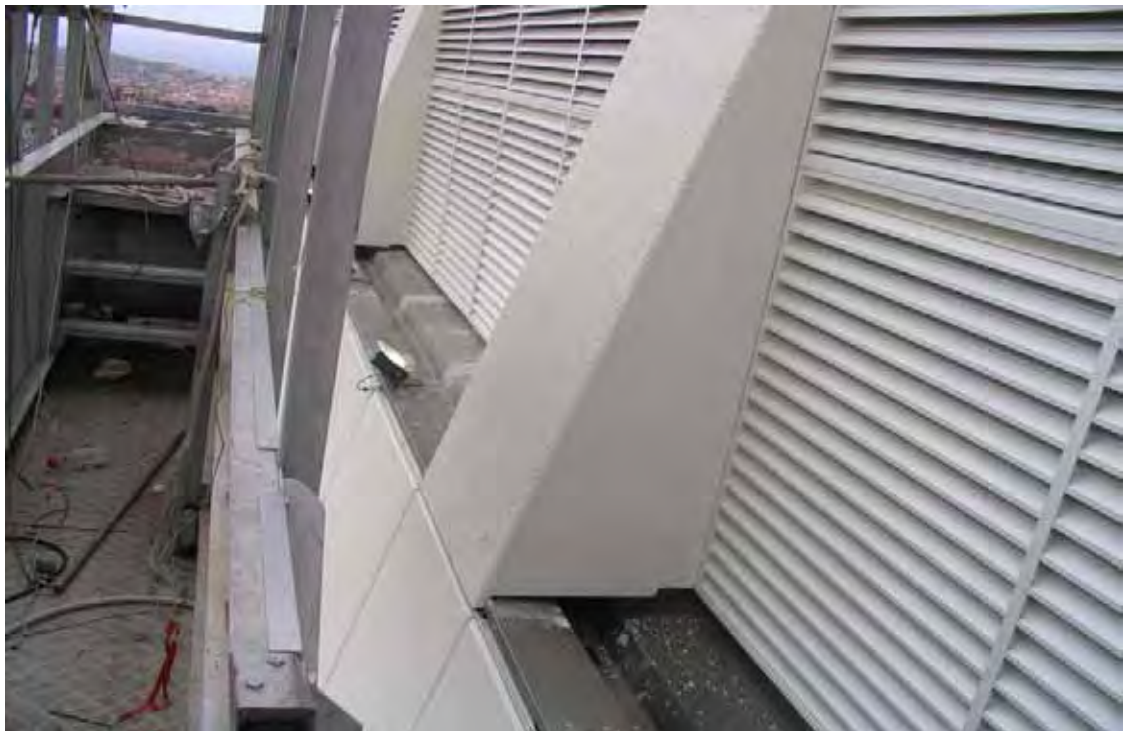
**Figure 4.12** Difficulty in working on louvres at lower section, where steel cradle structure on left hand side is BMU.

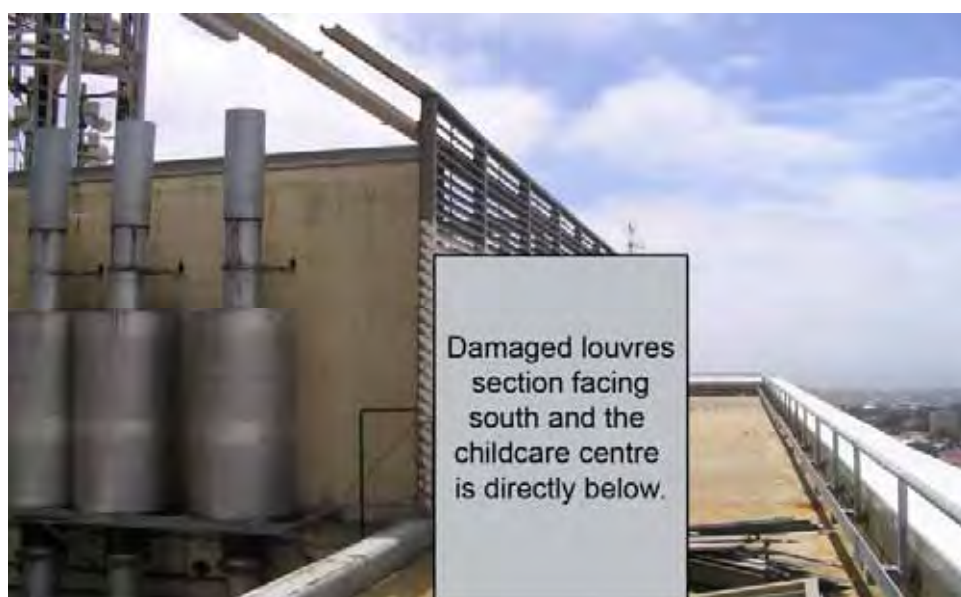
**Figure 4.14** Damaged louvre section on southwest corner of roof on level 29.

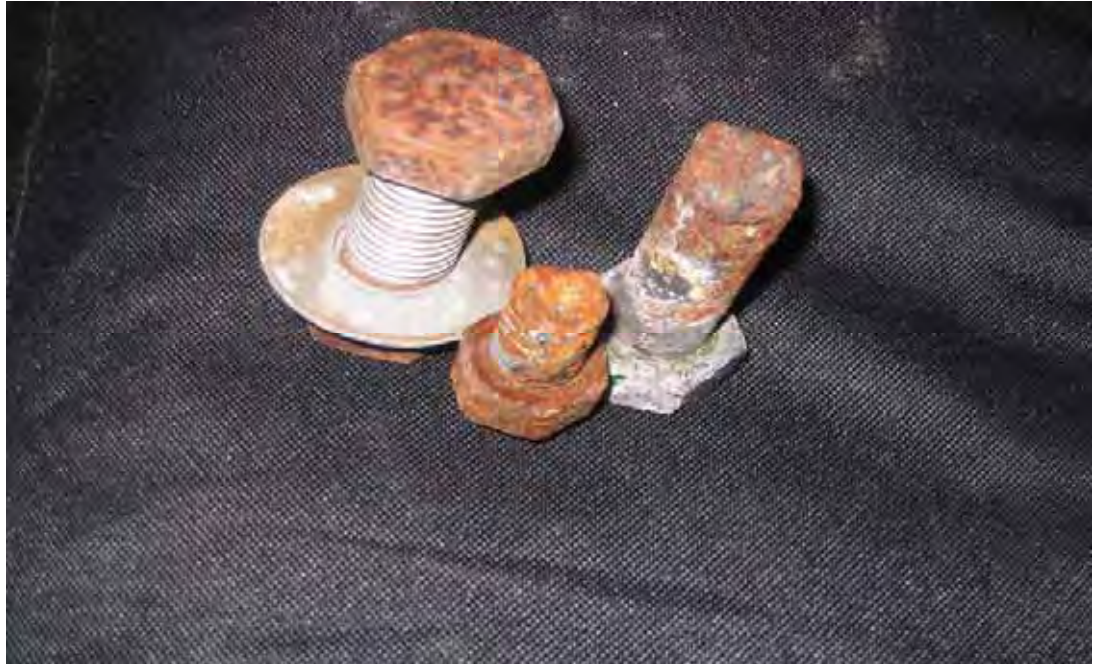
**Figure 4.15** Bolts failed due to corrosion and cyclic loading.

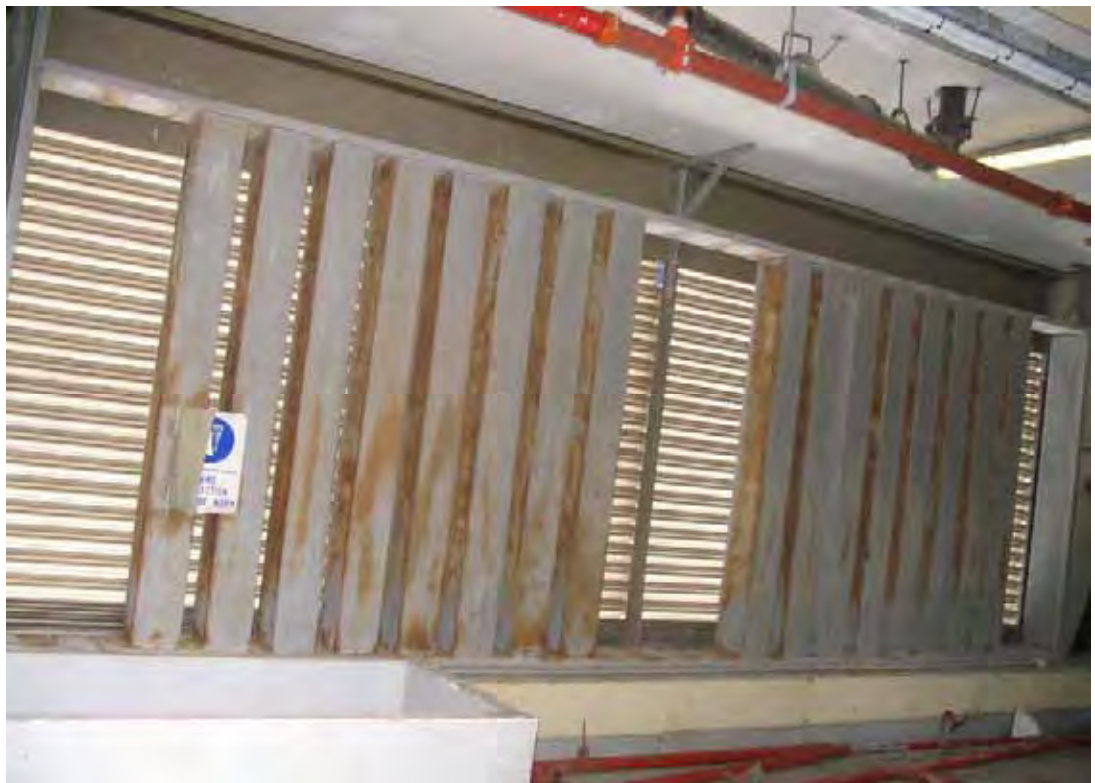
**Figure 4.16** Corroded noise attenuators or baffles adjacent to louvers on north, south, and southeast sections of level 28.

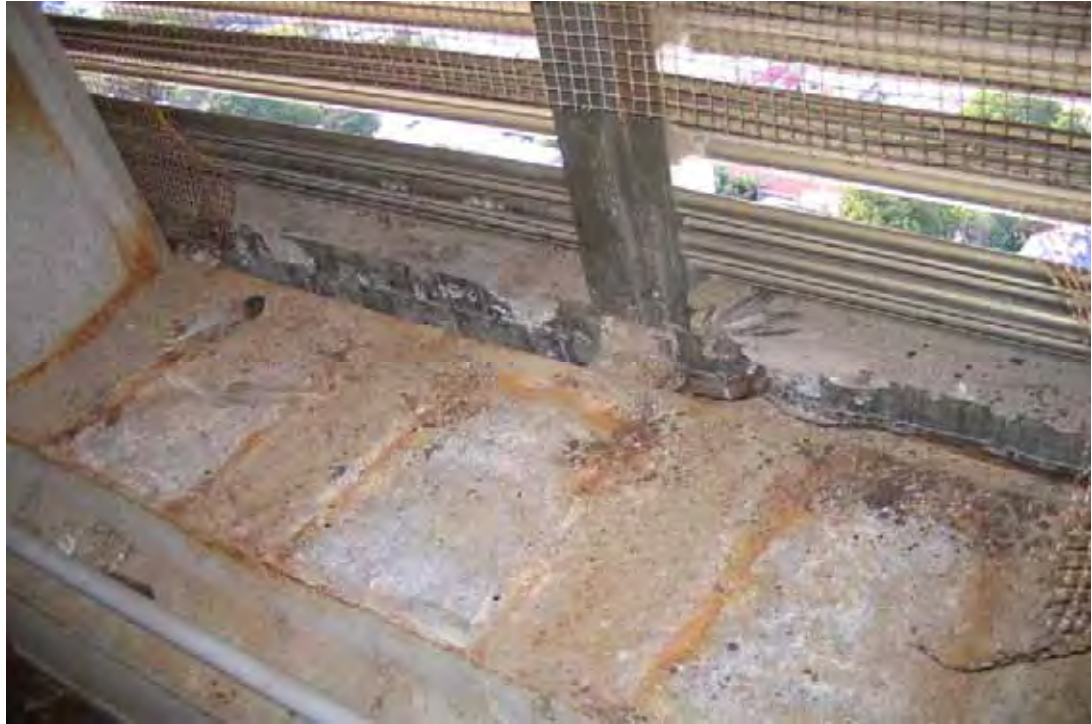
**Figure 4.17** Steel cladding extending from base of baffles and enveloping face mullion, causing galvanic corrosion.

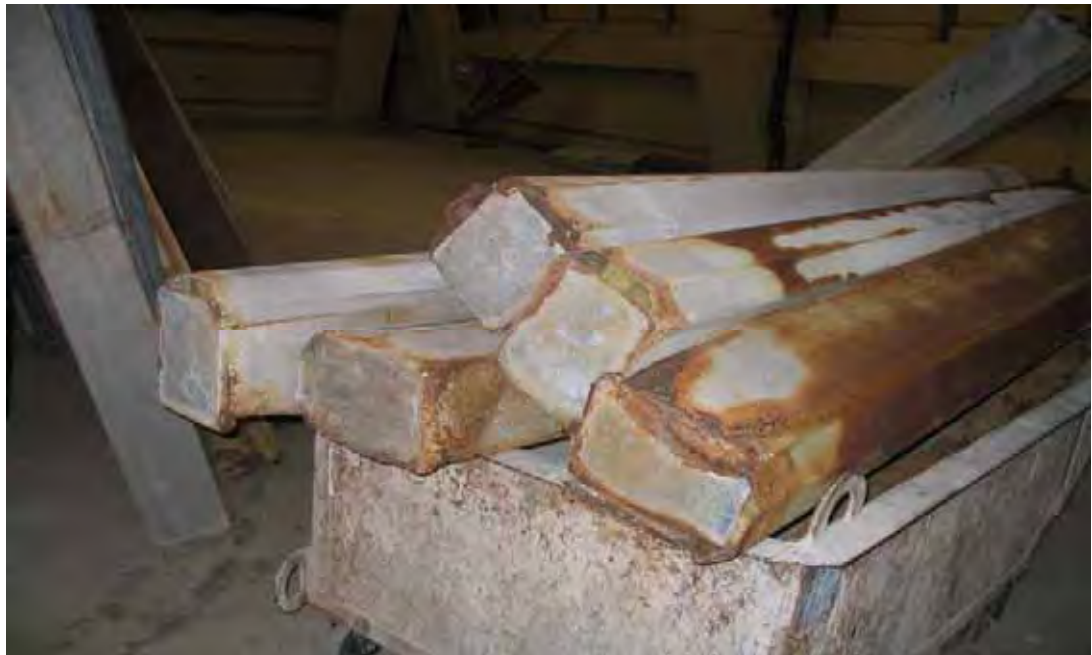
**Figure 4.18** Excessive corrosion in baffles in open area of level 28, caused as result of moisture retained in fibreglass.

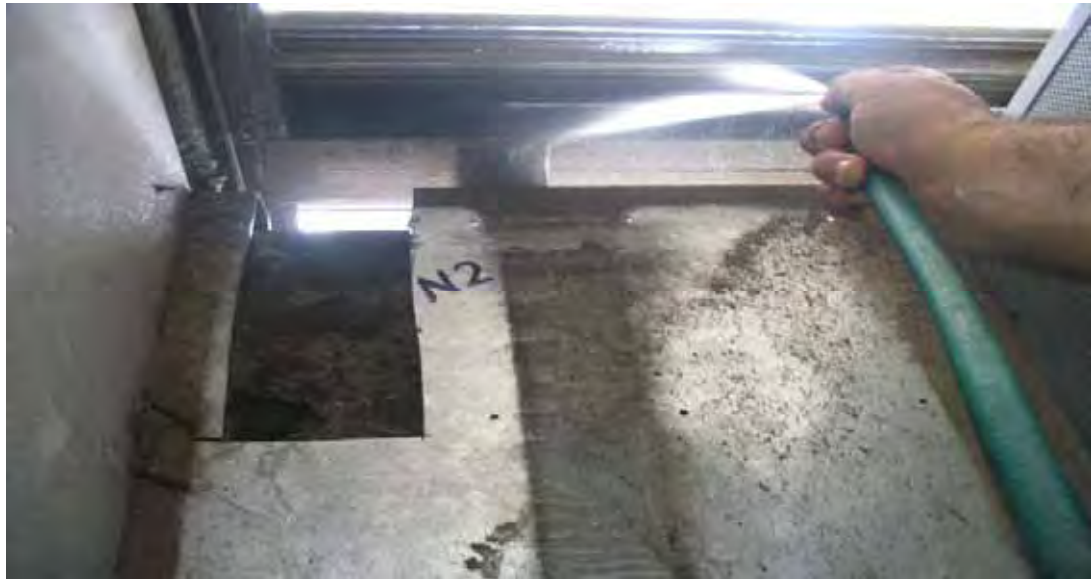
**Figure 4.19** Preparation and cleaning of mullions adjacent to baffles.

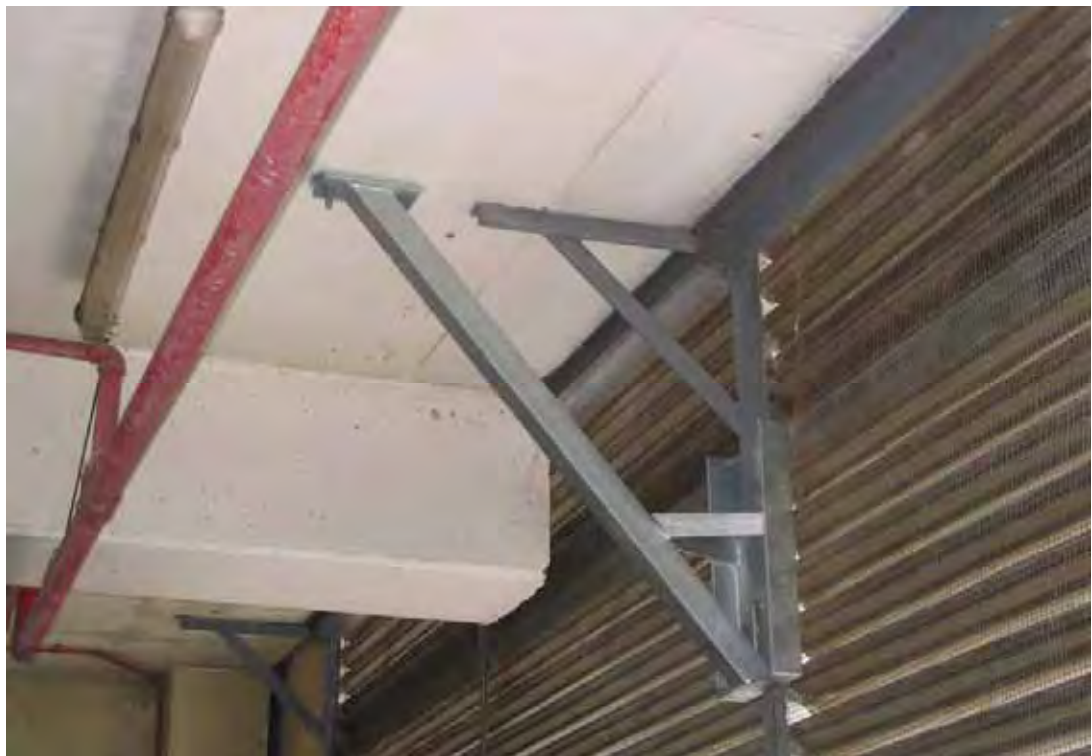
**Figure 4.20** Typical U-shaped brackets fabricated and hot dip galvanised for upper sections of louvres on level 28.

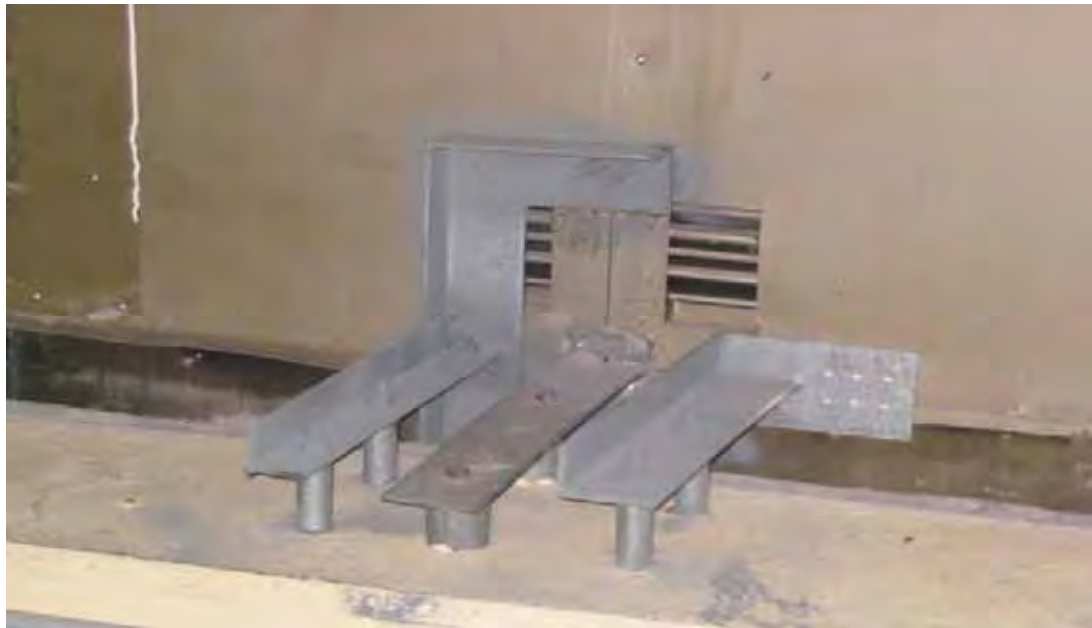
**Figure 4.21** Typical C-brackets, left-hand side fabricated and hot dip galvanised for lower sections of level 28; additional brackets on right-hand side wall support remainder of mullions.

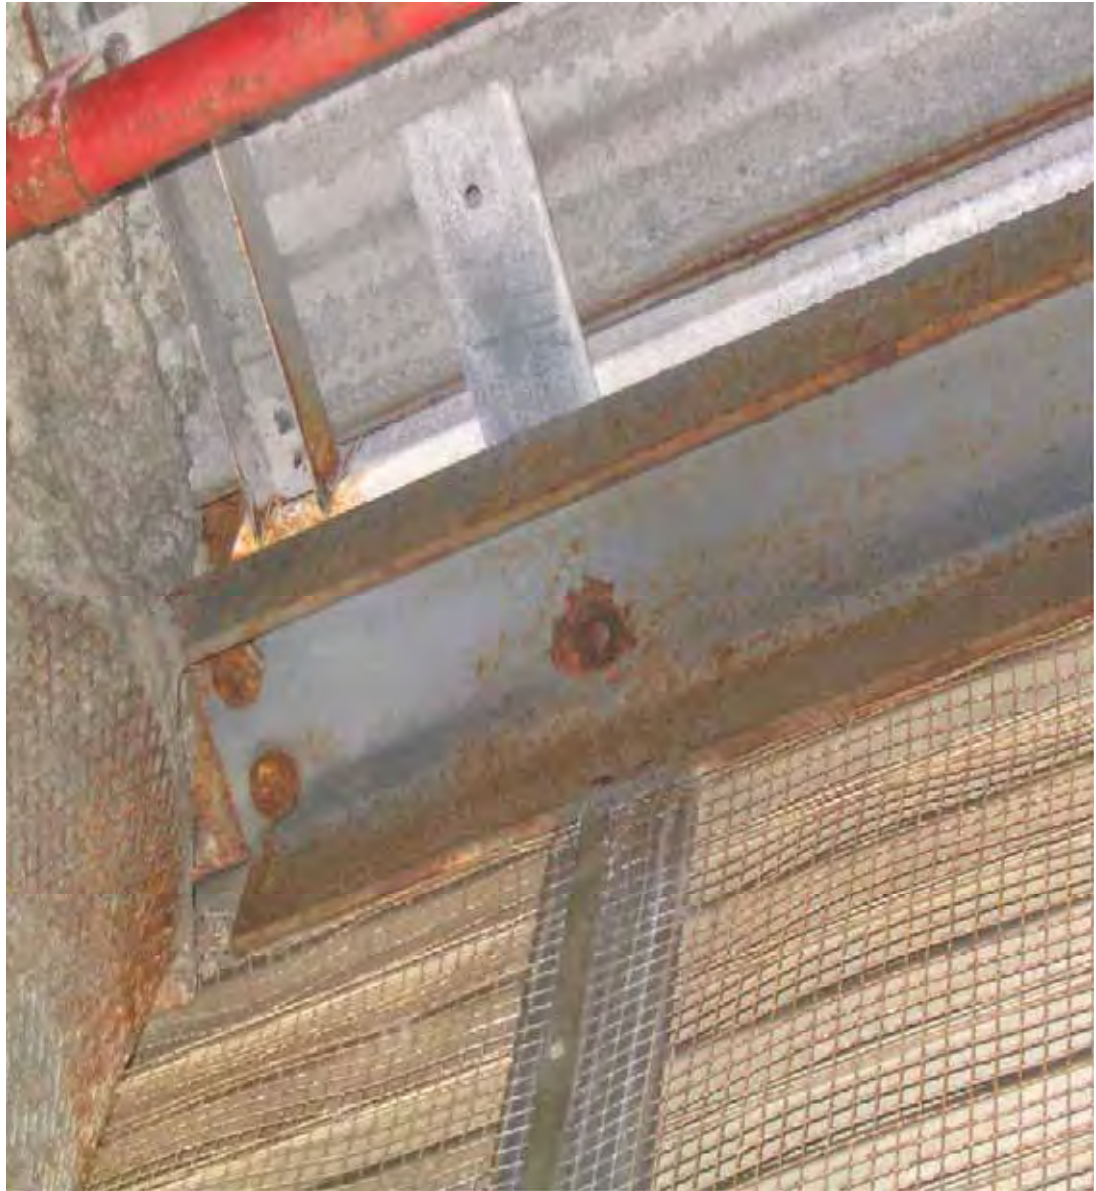
**Figure 4.23** Corroded bolts and corroded PFCs as main structural supports for louvres on level 29; roof and horizontal PFC encourage indefinite corrosion deposits.

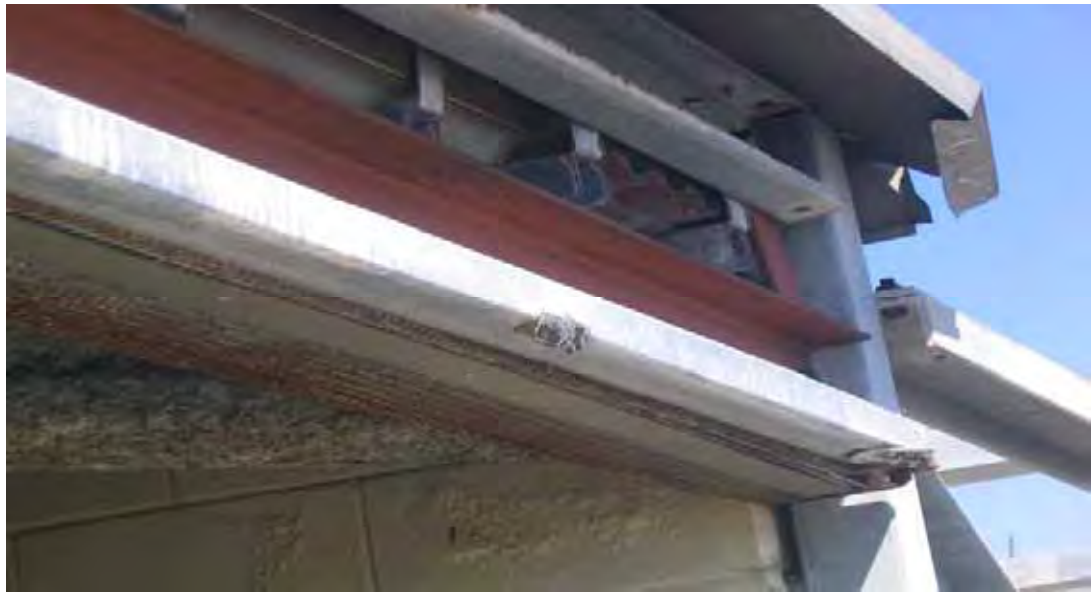
**Figure 4.25a** Structural beam holding roof with inadequate support beneath should existing corrosion continue at same rate.

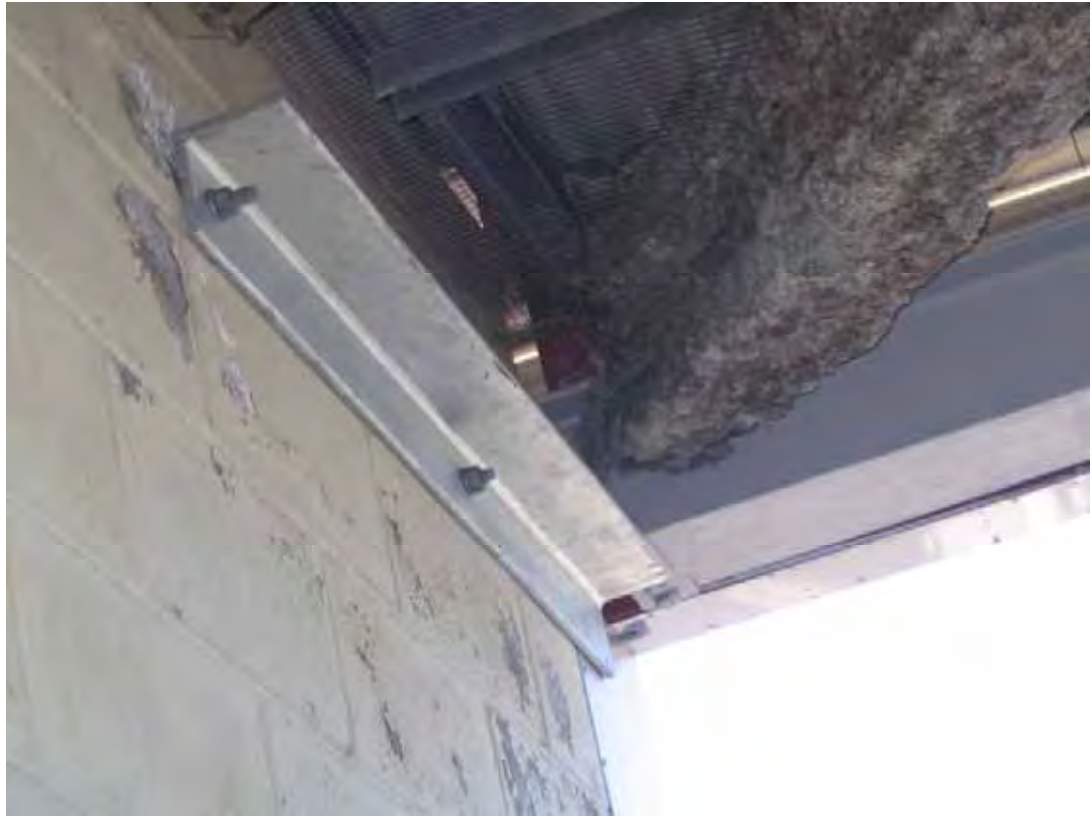
**Figure 4.25c** Hot dipped galvanised structural angle chemset into wall directly beneath beam for additional support.

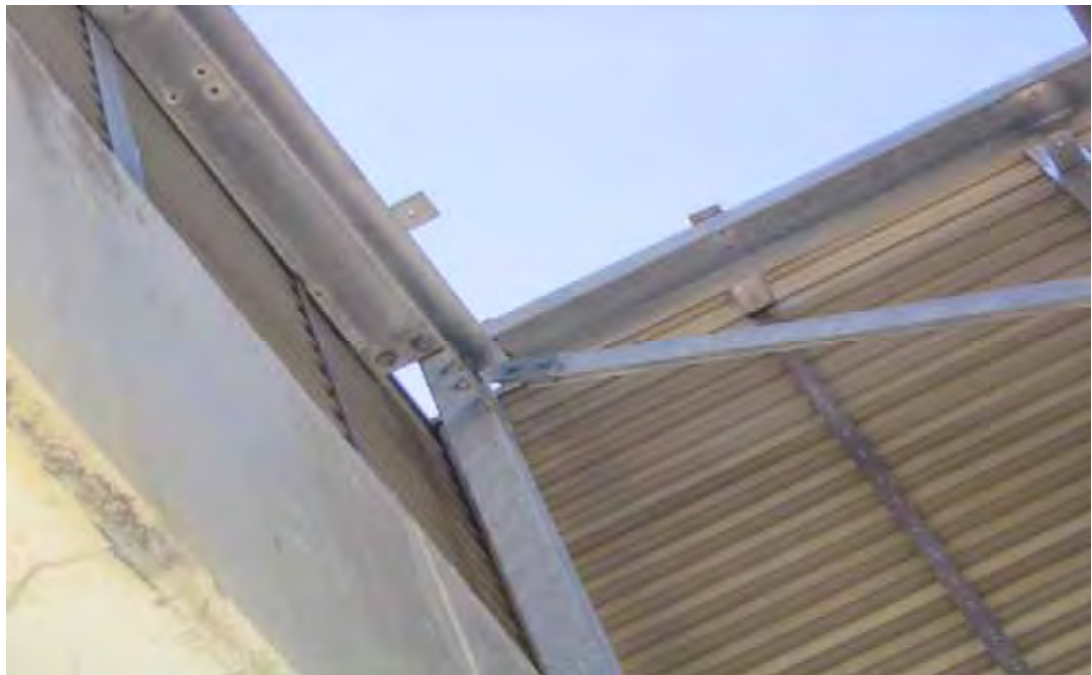
**Figure 4.26** Corroded bolts replaced with new structural galvanised bolts; old brackets held onto PFC using one or two corroded bolts; brackets held to structural mullion with one or two tek screws.

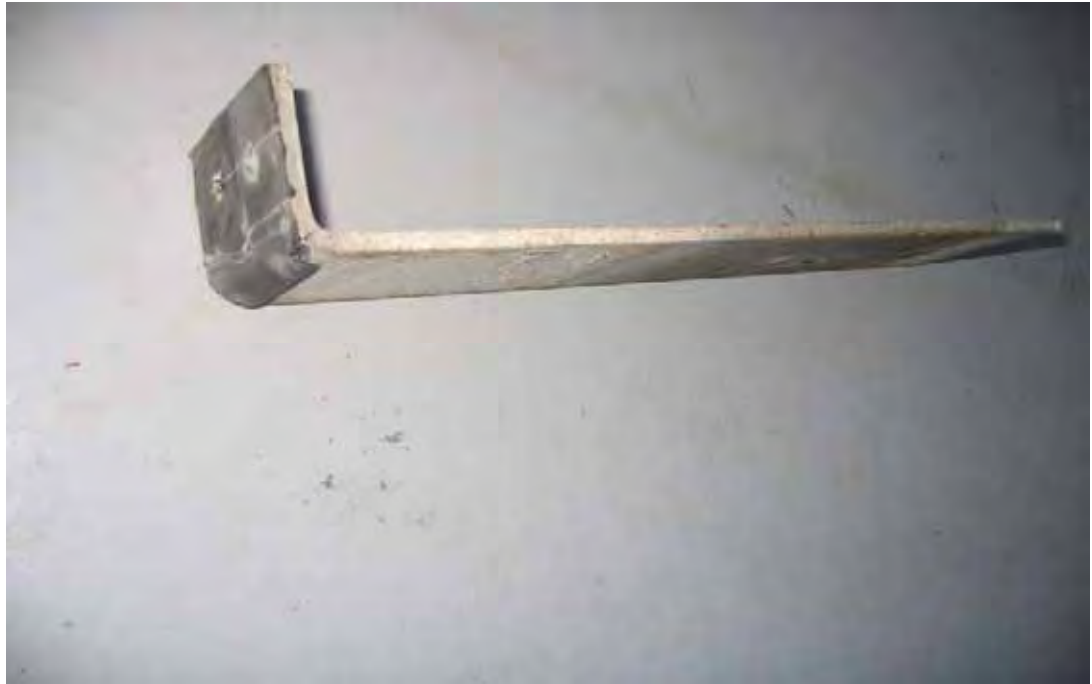
**Figure 4.27** Rounded old brackets with cracks at radius.

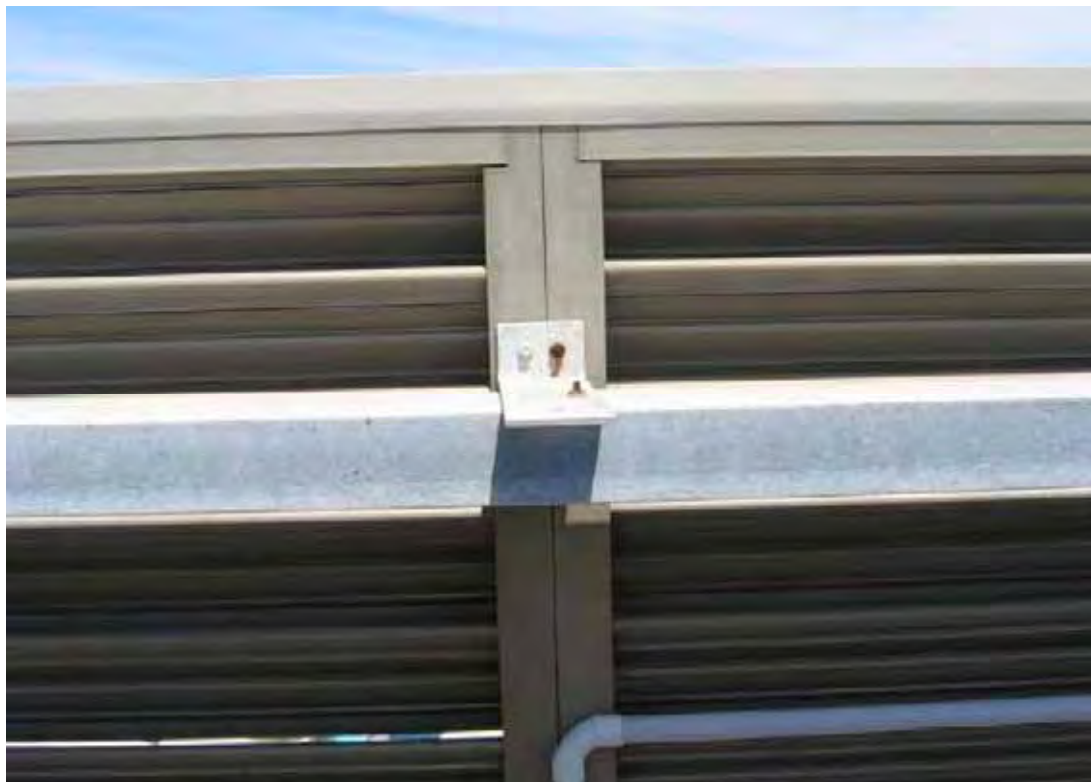
**Figure 4.28** Corroded 6 mm tek screws barely holding structural louvres through rounded brackets; typically one corroded bolt connected to the structural PFC; one of principal reasons for failure of southwest corner.

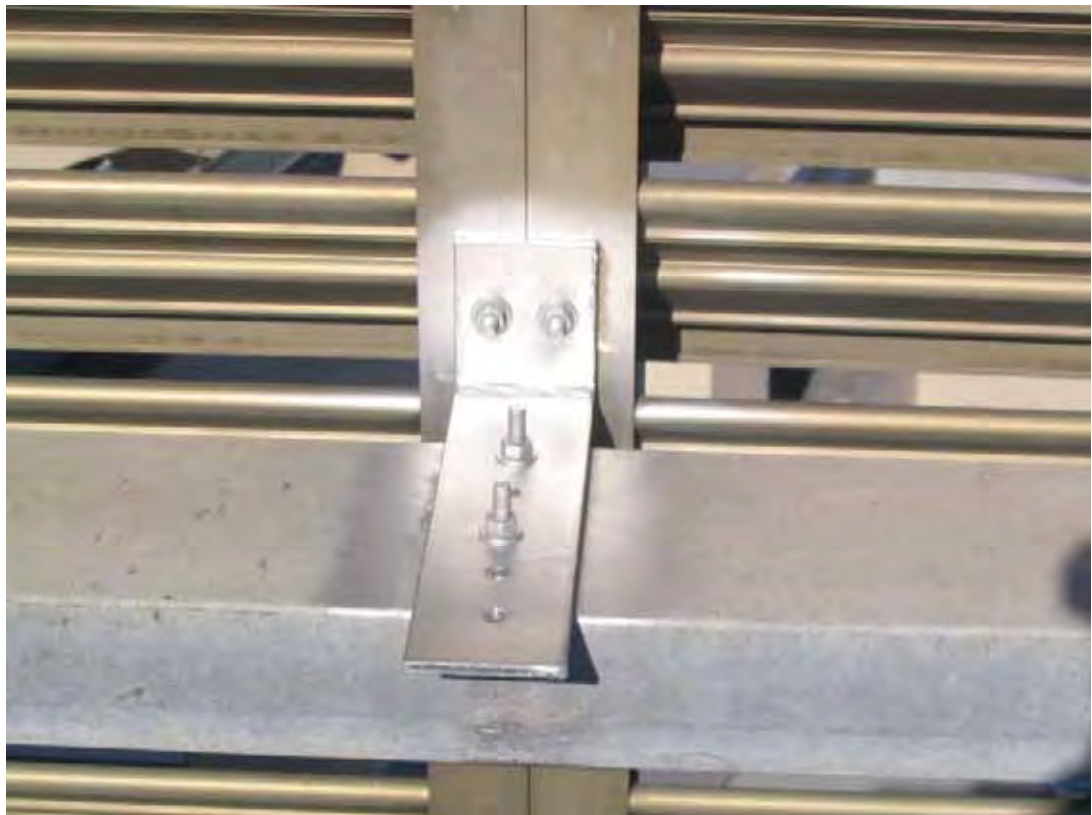
**Figure 4.29b** New hot dip galvanised brackets designed for optimal strength, connected with structural galvanised M8 bolts through mullion and into bracket; structural galvanised M8 bolts connecting bracket to PFC.

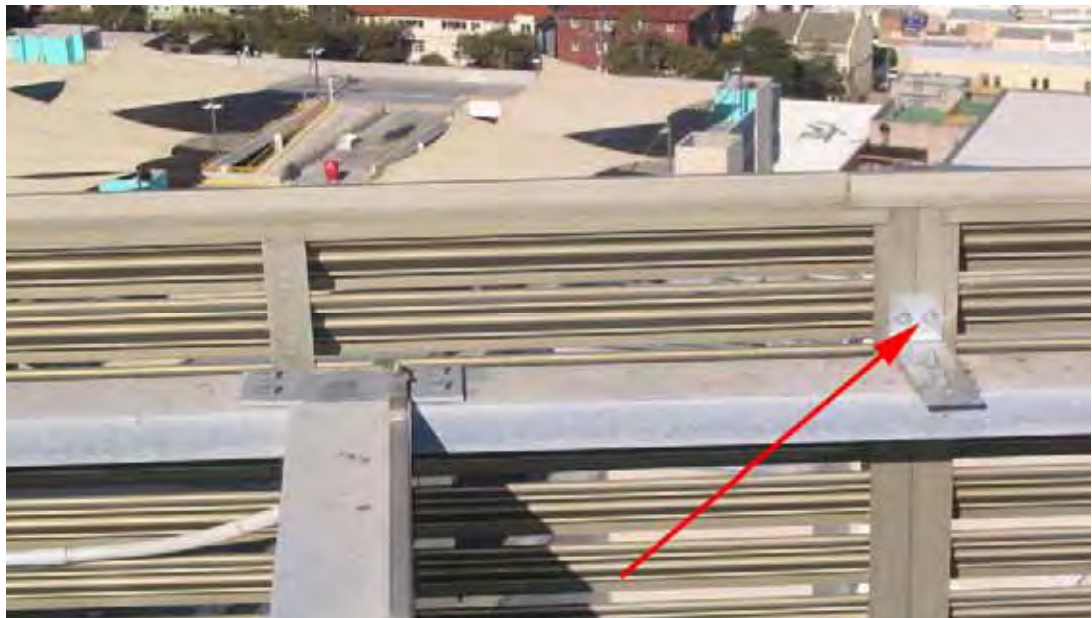
**Figure 4.31** Typical connection for each bolt in each vertical mullion.

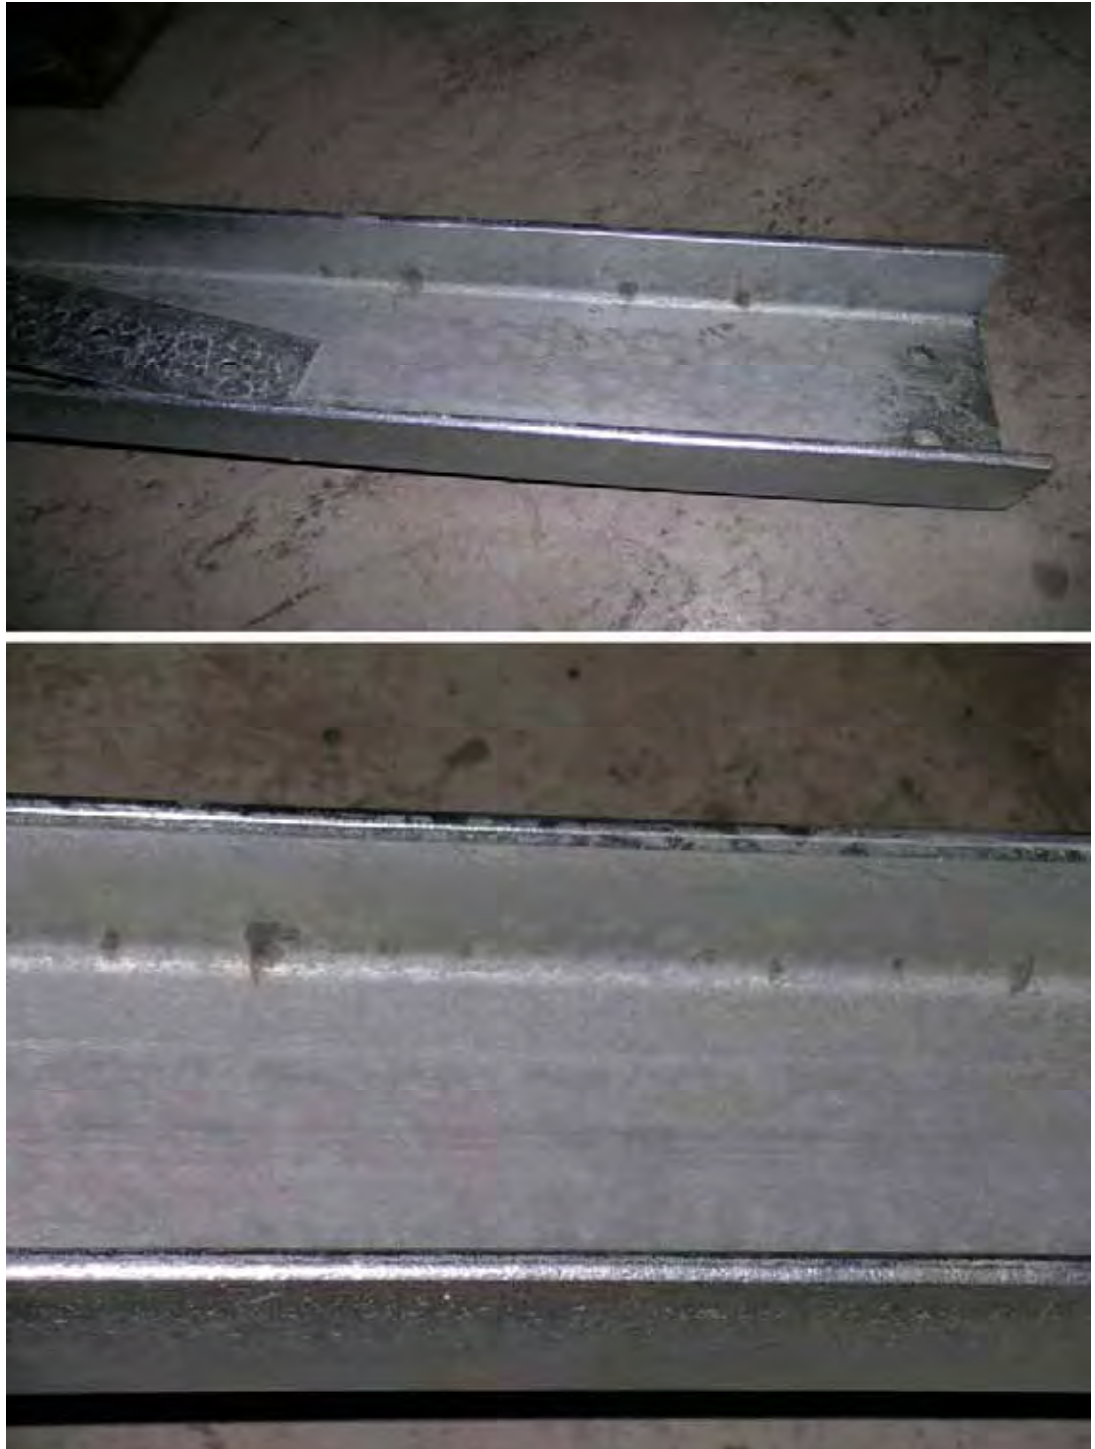
**Figure 4.32** Chips of galvanised surface removed.

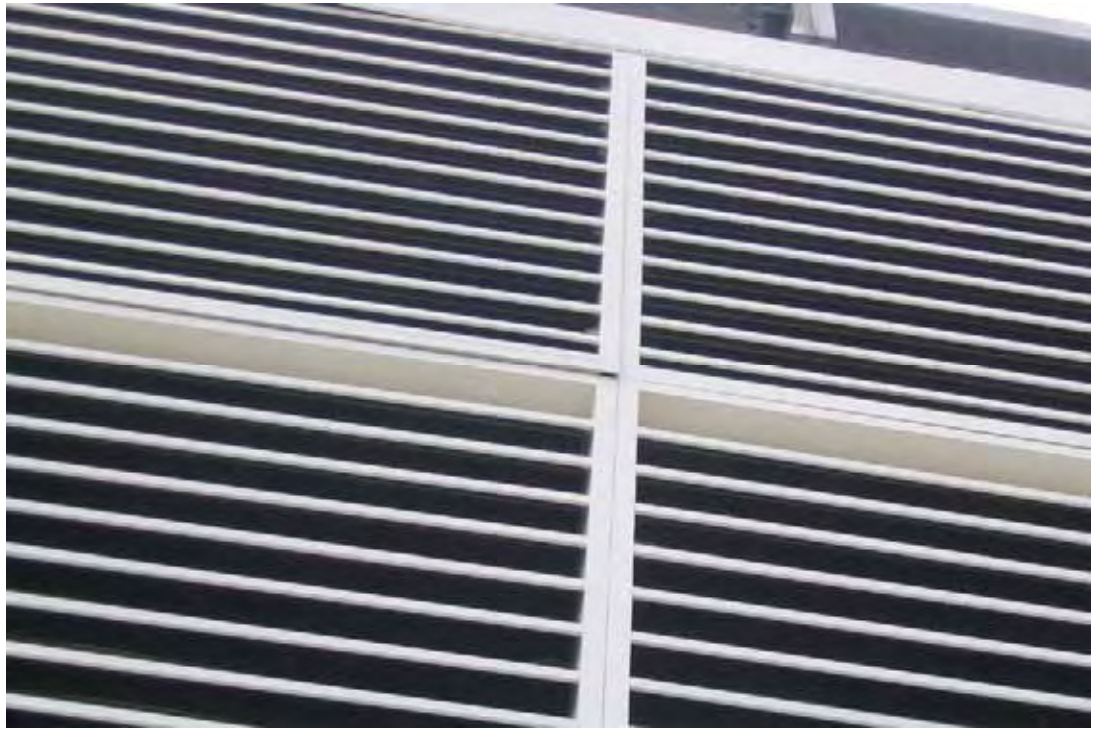
**Figure 4.33** One of four typical louvre panels sitting loose due to incorrect and inadequate connection.
