# Design variables for steel and aluminium in high-rise rooftops

# **Design Variables for Steel and Aluminium in High-Rise Rooftops**

This dissertation reports a case study in the design and construction solutions for a major corrosion failure of the aluminium louvres and steel brackets on the roof and façade of levels 26-29 of the Westfield Tower 2, Bondi Junction. This work was undertaken during early 2005.

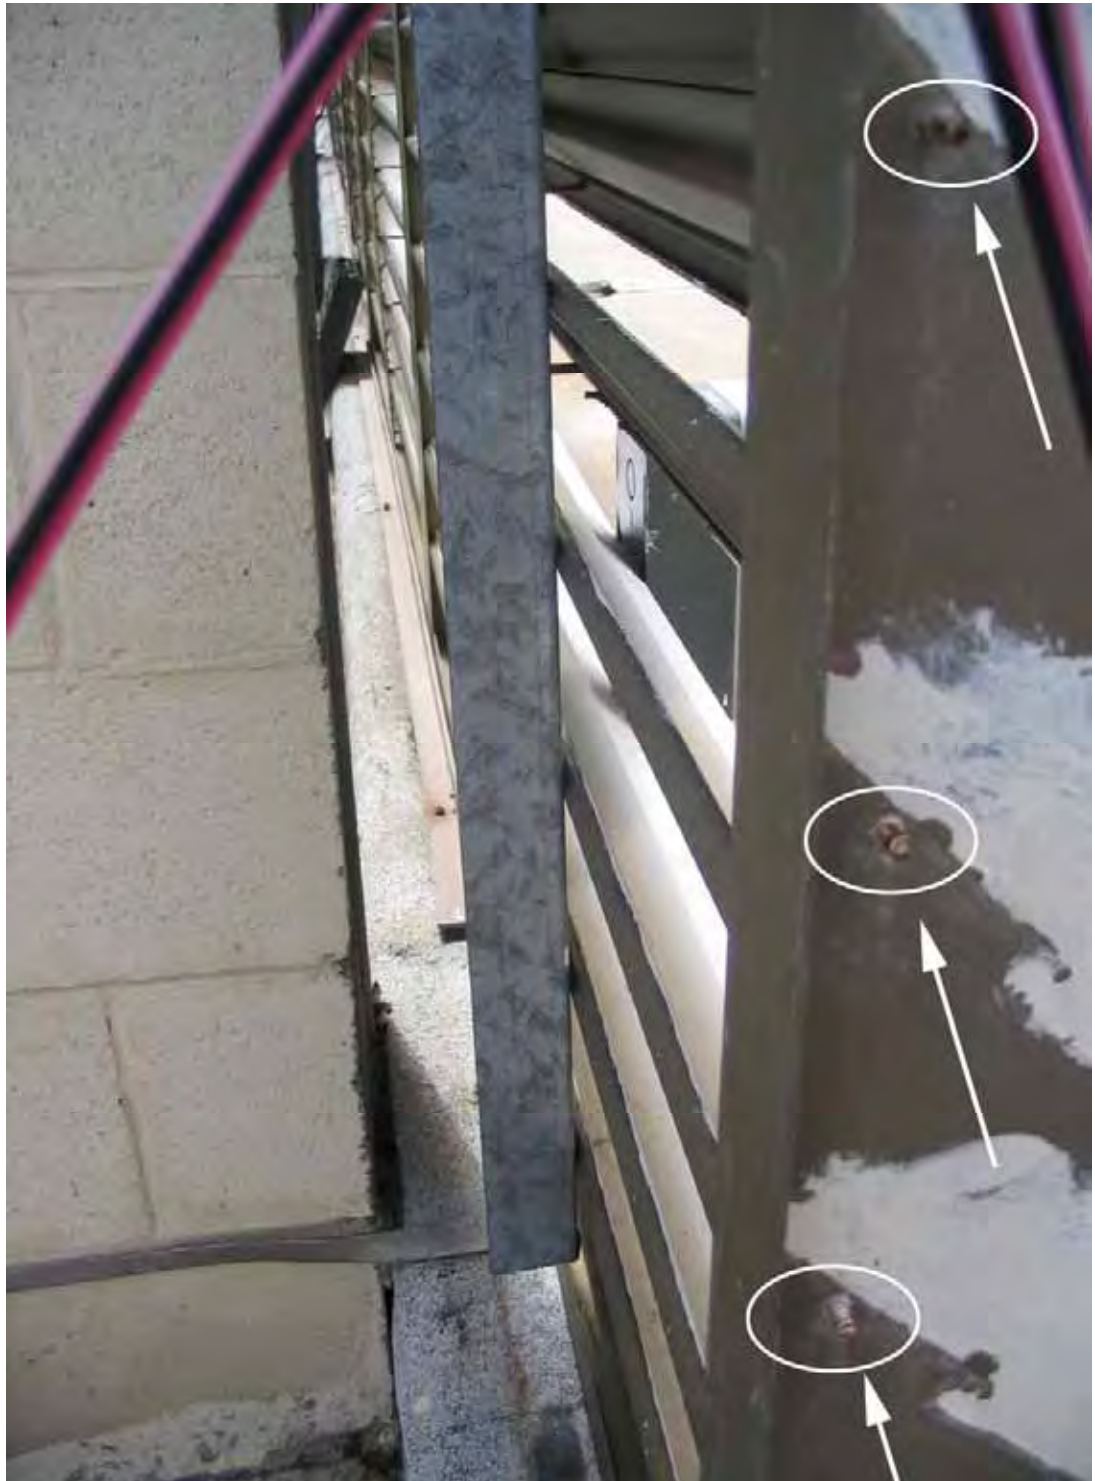
**Figure 4.35** Corroded screws typical of all existing Westfield louvre connections in mullions.

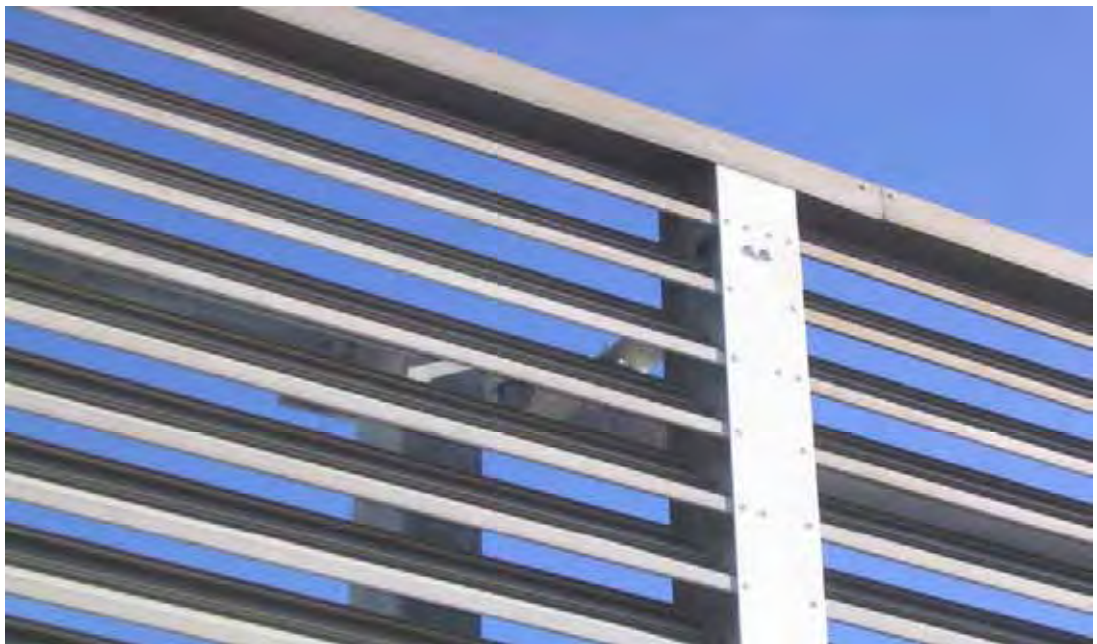
**Figure 4.37** M8 bolts residing on 2.54 mm 6061 aluminium strip for added strength, connecting through mullion to new PFC.

From Table 5.2, Figures 4.37 and 4.38a indicate minimal and maximal ESLCs of 14 and 35 years, respectively, for the bolt, which has two large dome heads (top of photo). However, the bolt was powder coated, thereby adding to its corrosion resistance and probable lifetime. This configuration was chosen so that it would minimise the potential for tearing should there be excessive pull from the brackets on the other side, which in turn were supported on the PFCs. These bolts passed right through the mullion to connect to the brackets mentioned above for Figures 4.29-4.31. This arrangement provided secure attachment between the brackets, PFCs, and louvre system, ensuring minimal movement. Consequently, the lifetimes of these components could be expected to be increased over those of the ESLCs (owing to the reduced effects of the wind load on the louvre system).

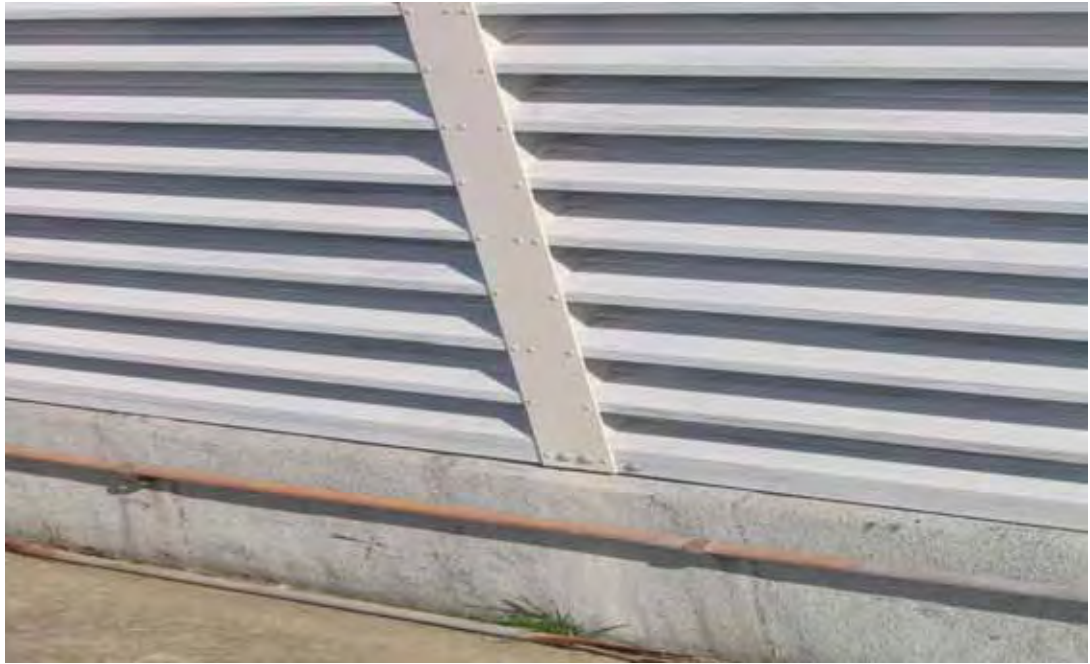
**Figure 4.38a** M8 bolts connecting to equal angle on hob on other side.

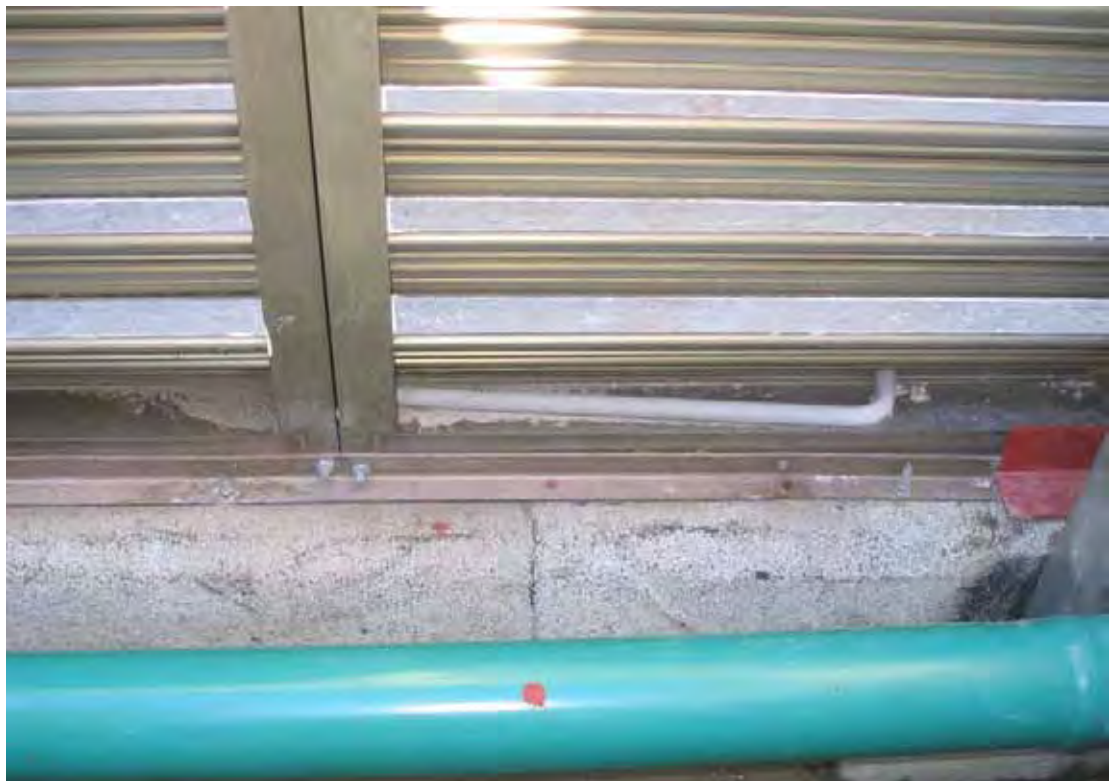
**Figure 4.38b** M8 galvanised bolts connecting to existing equal angle with M8 chemically set bolts into equal angle and hob for extra strength against wind uplift or lateral forces.

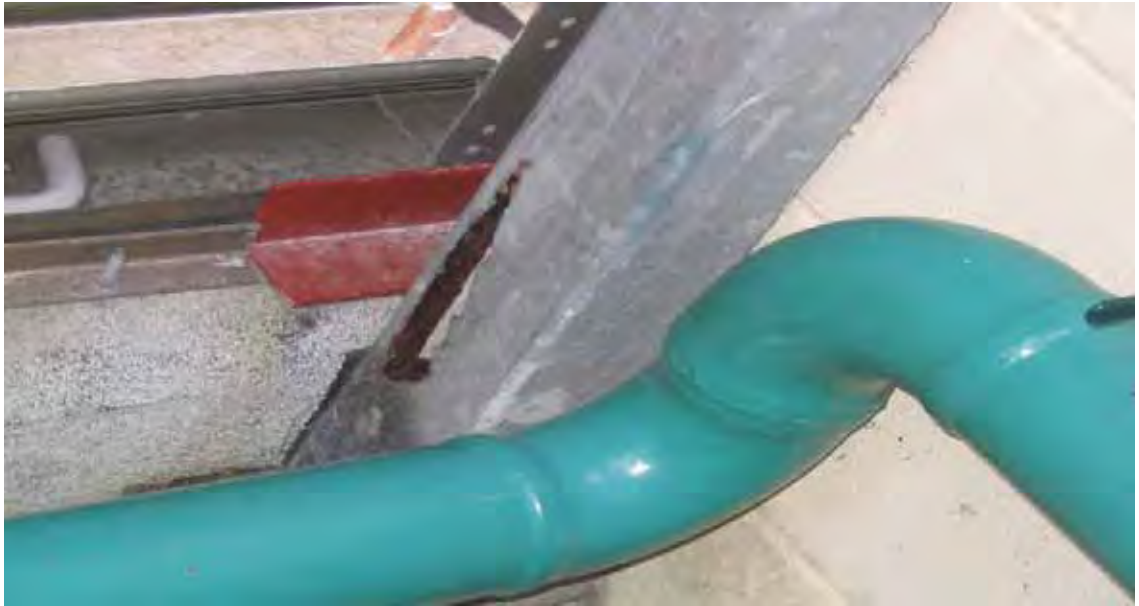
**Figure 4.39** Corroded column on southern face near western section owing to holes' not being plugged on top of columns after galvanising during original fabrication.

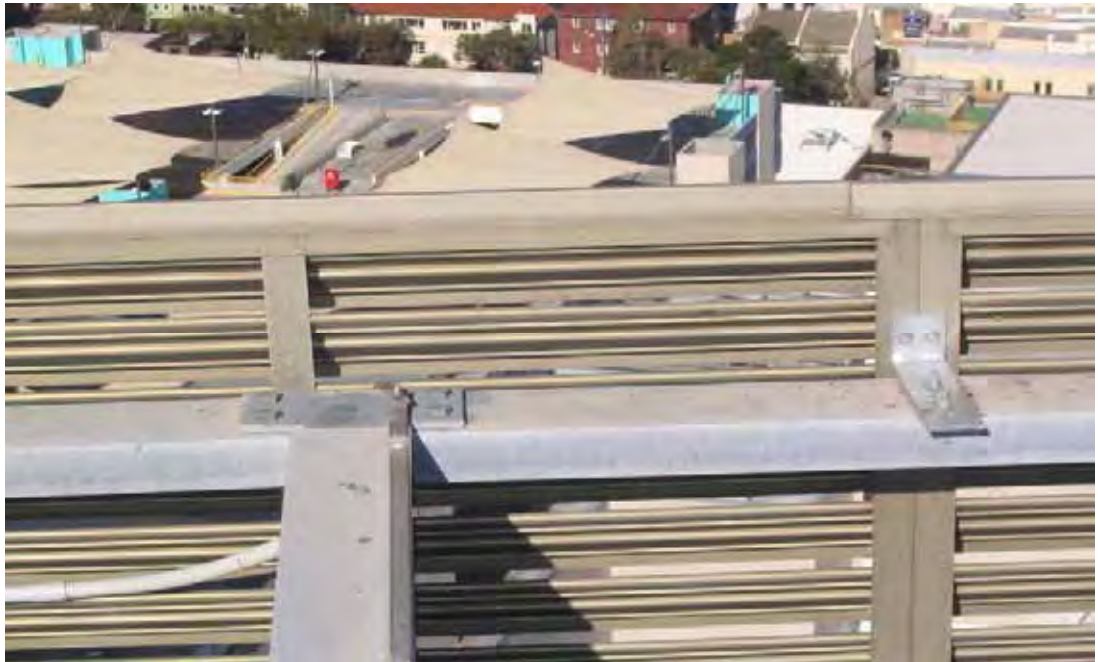
**Figure 4.41** Holes on column left hand side plugged with special two-mix steel putty.

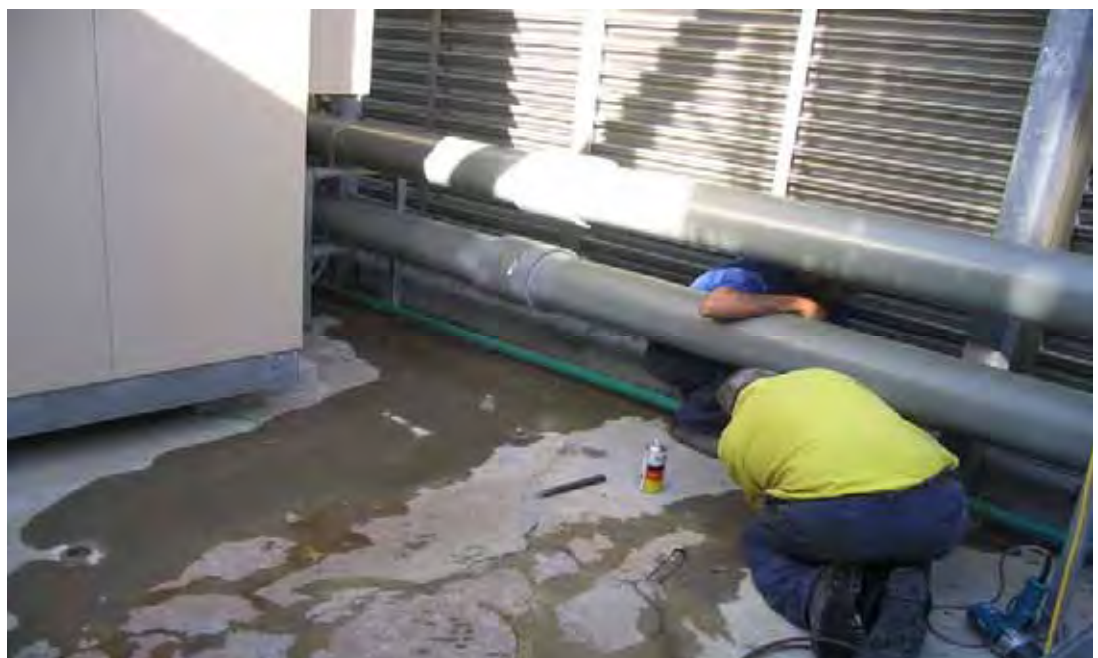
**Figure 4.42** Water draining from columns due to drilling at base of each of columns to allow bleeding of excess water.

Figure 4.42 illustrates the holes' being drilled at the base of the columns in order to expel water and subsequently being dried with an air hose, after which coldgal, *Emerbond*, and *Emerclad* were applied. Table 5.2 indicates that, from the guarantees for *Emerbond* and *Emerclad*, an ESLC is merited. However, the life of this component

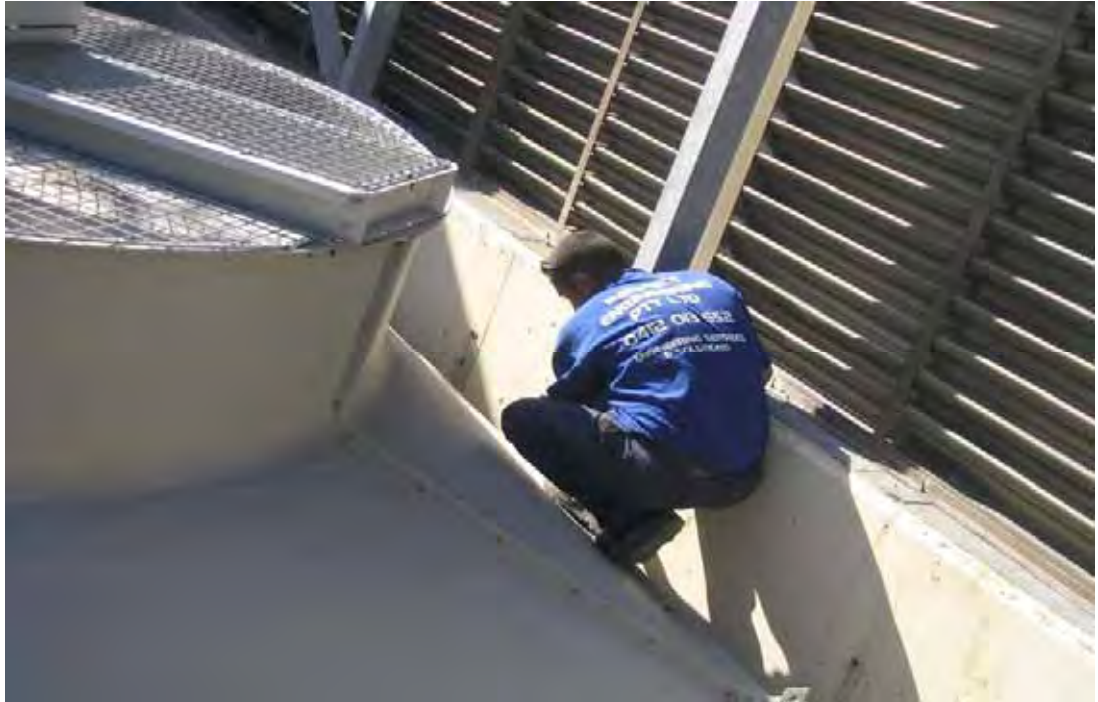
**Figure 4.43** Residue build-up in six vertical columns facing south requiring no bleeding as access to holes was open.

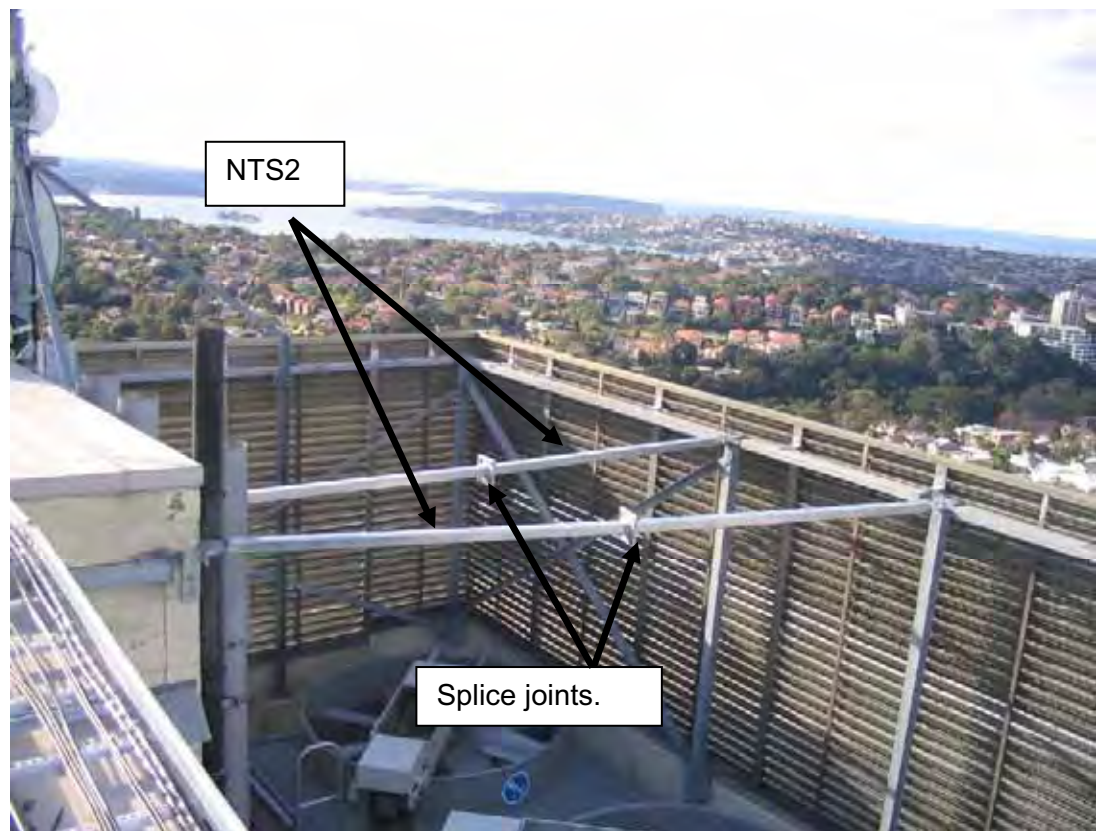
**Figure 4.46** Hot dip galvanised cross beams (NTS2) and brackets designed to provide further structural support for eastern section of louvres.

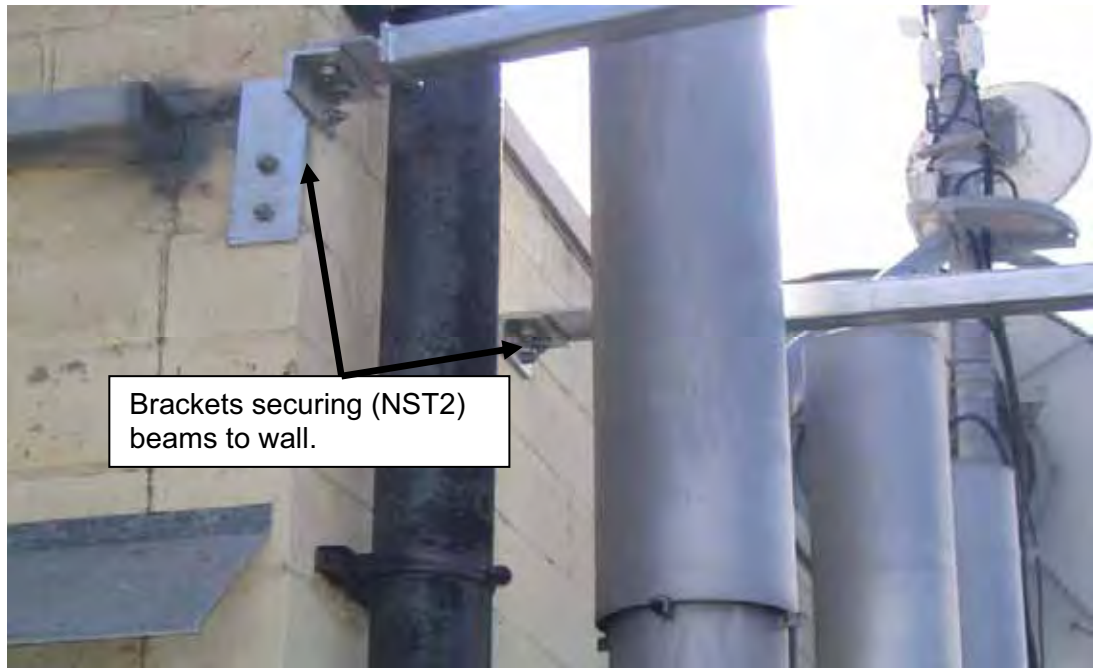
**Figure 4.47** Intricate connection of brackets to wall using chemical anchoring.

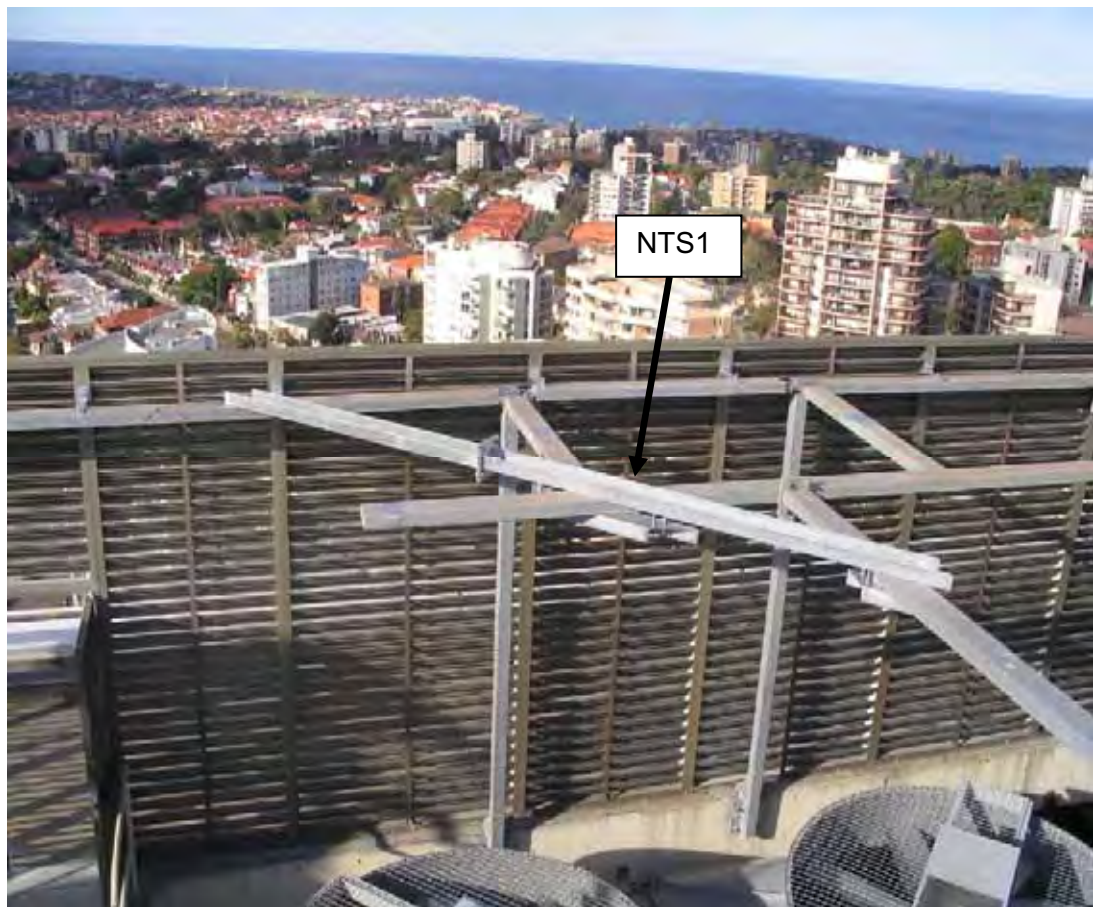
**Figure 4.48b** Top view of connection detail of cross beams (NTS1) and brackets using PFCs for additional strength on eastern face.

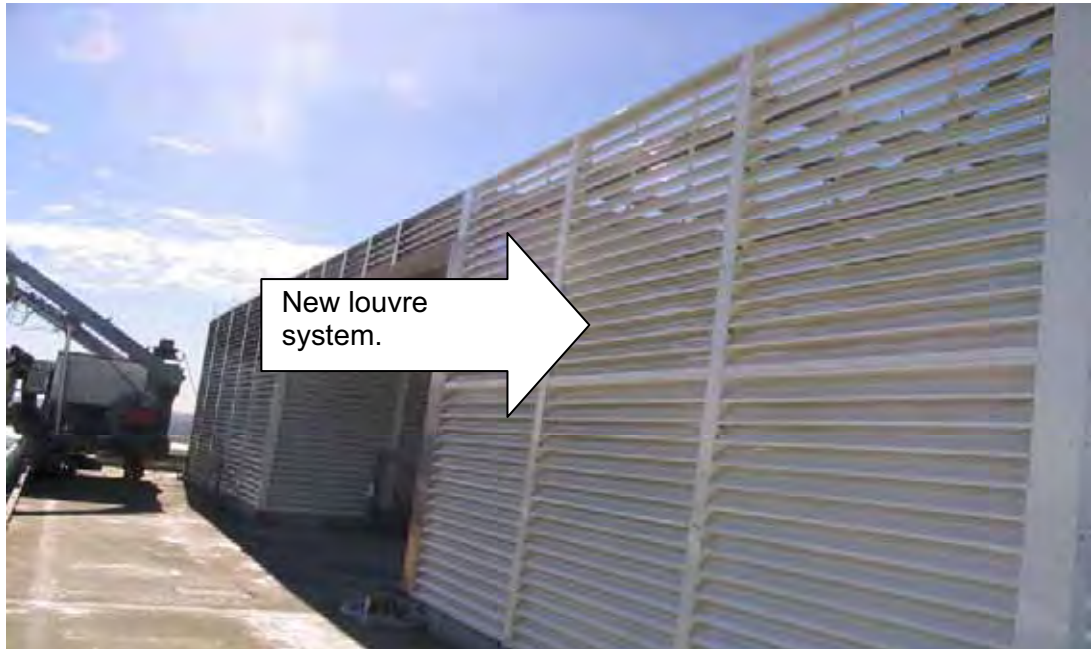
**Figure 4.49a** New southwest louvre section; each louvre fully welded to mullion and powder-coated.

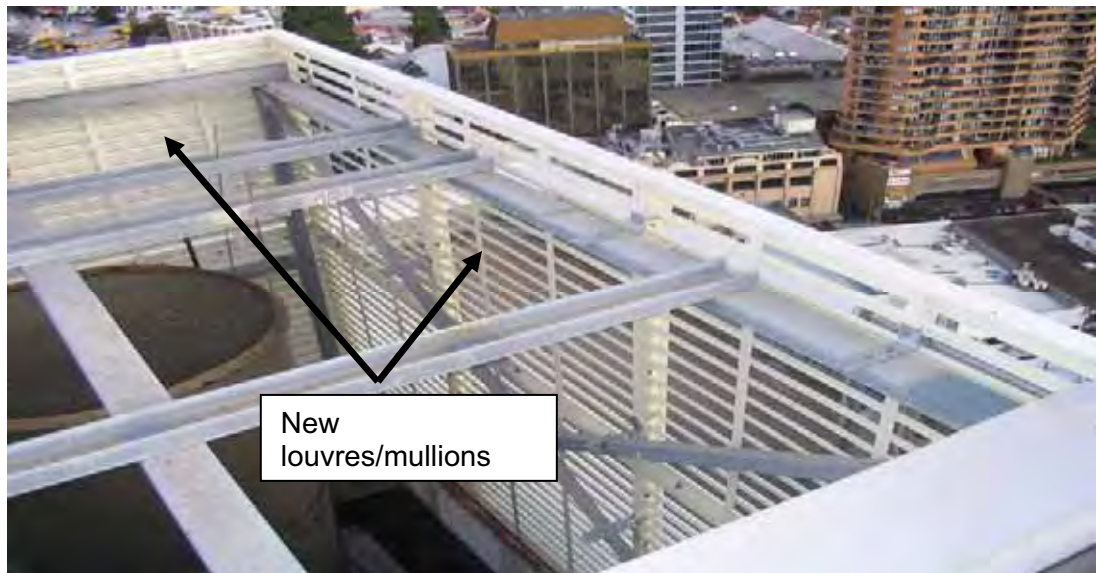
**Figure 4.49b** Top view of new southwest louvre section, showing details of connections installed at every major structural position.

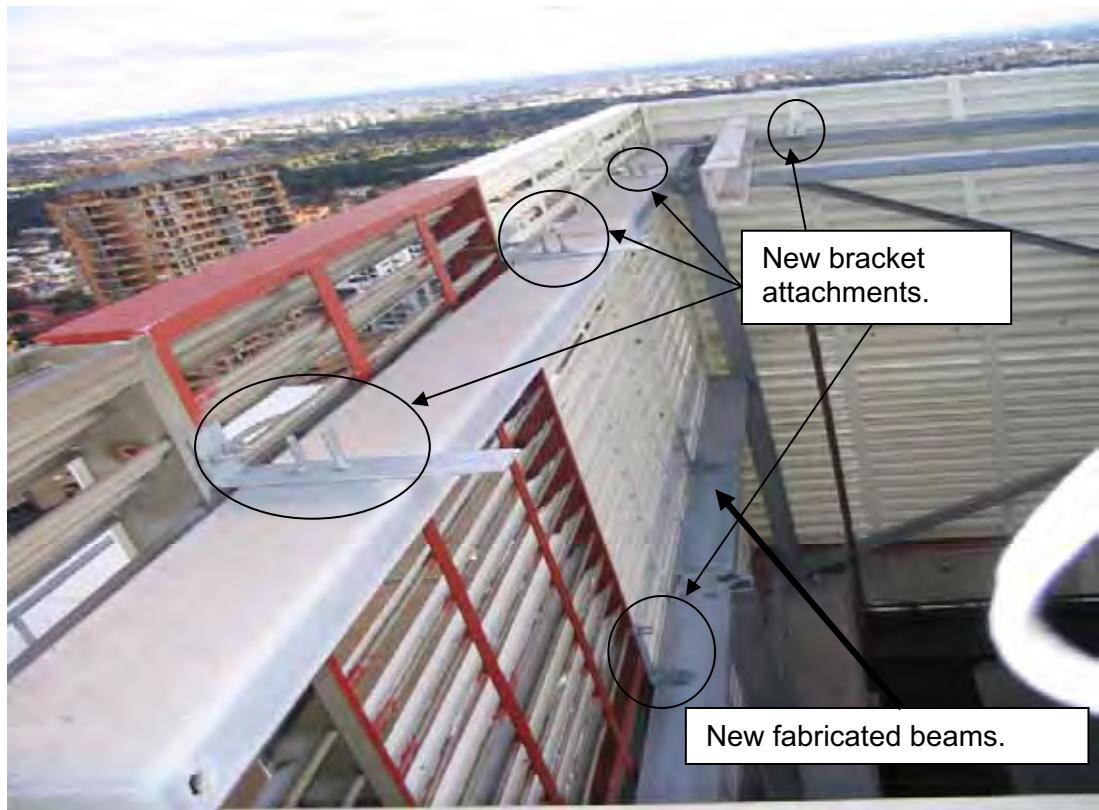
**Figure 4.50a** Panel section (with red primer) facing south fabricated fully using existing louvres.

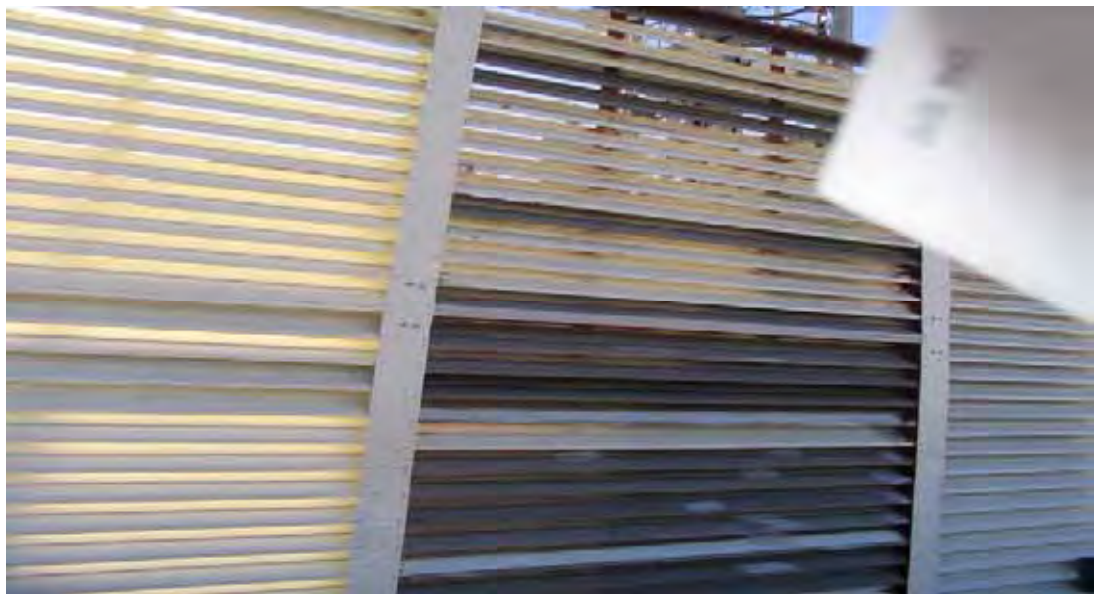
**Figure 4.50b** Panel section facing south as fabricated using existing louvres.

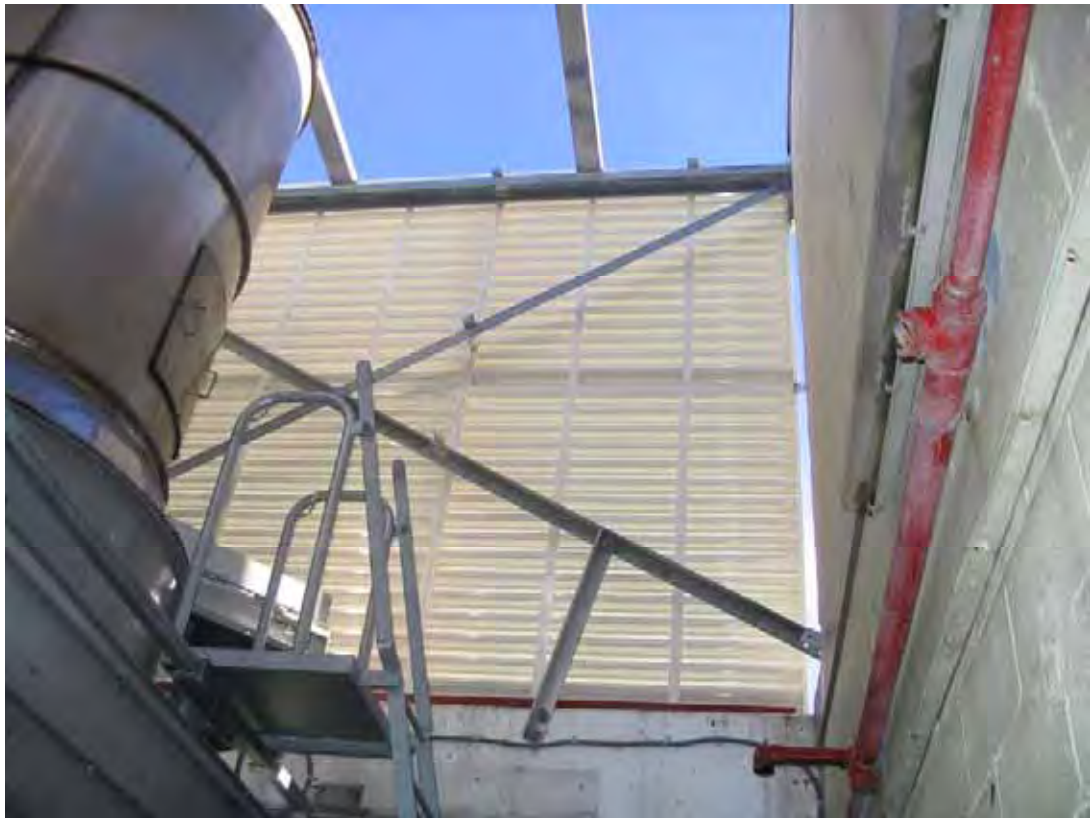
**Figure 4.51** Several additional hot dip galvanised brackets and connections utilised to give further strength to western side.

To be safe, additional strengthening of the louvre frames was done by constructing structural support for the PFCs and chemical anchoring of the supports to the concrete hob, and EA to the wall as shown in Figures 4.51 to 4.53. The main benefit imparted to these welded mullions/louvres is that they have been powder coated as an extra precaution against corrosion as well as for a suitable aesthetic appearance. This will increase the corrosion resistance immensely, especially in the weakest positions (weld joins), where localised attack may occur if unprotected. The chances of corrosion on the weld join therefore are minimised and longevity is almost assured by this process. Since the welded zone would almost definitely be the weakest zone in the welded aluminium section, it is ideal to have this area specifically coated for as long a period as possible.

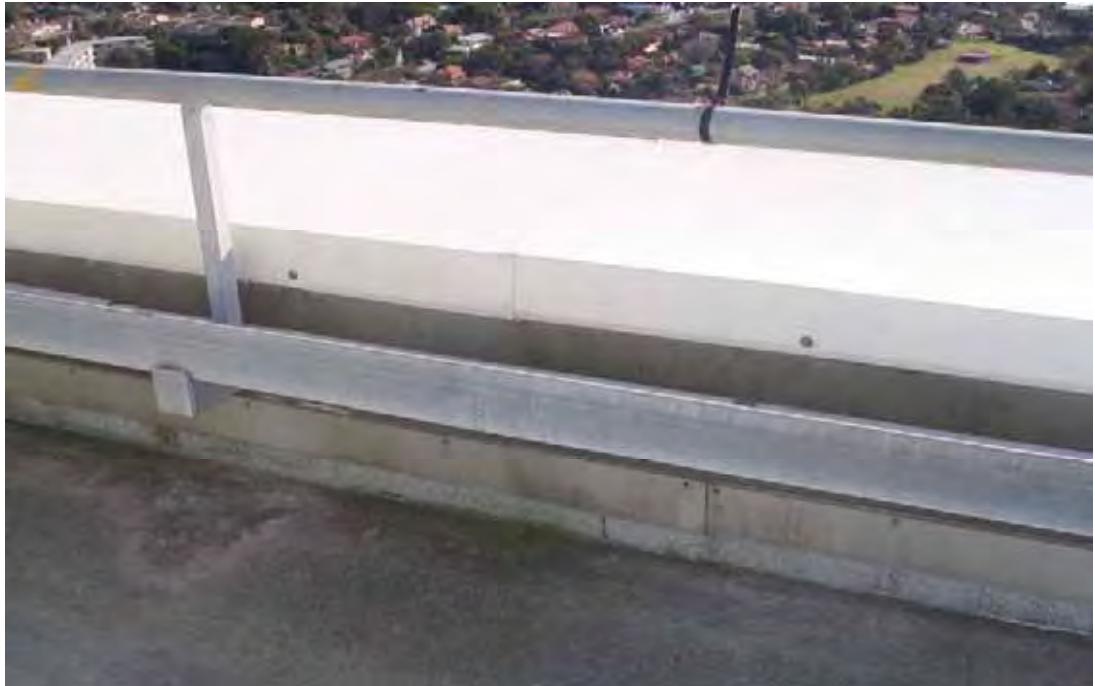
**Figure 4.55** Typical section of cladding on level 29, showing M8 dynabolts fixed to concrete hob using washers to avoid tearing effect; galvanised bolts placed all around parapet with appropriately sized galvanised washers.

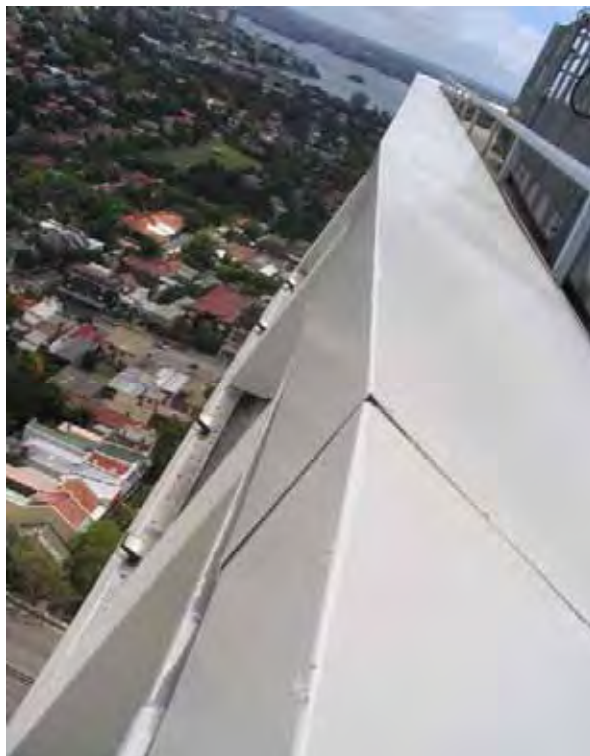
**Figure 4.56** Typical cladding separation from mullion sections throughout.

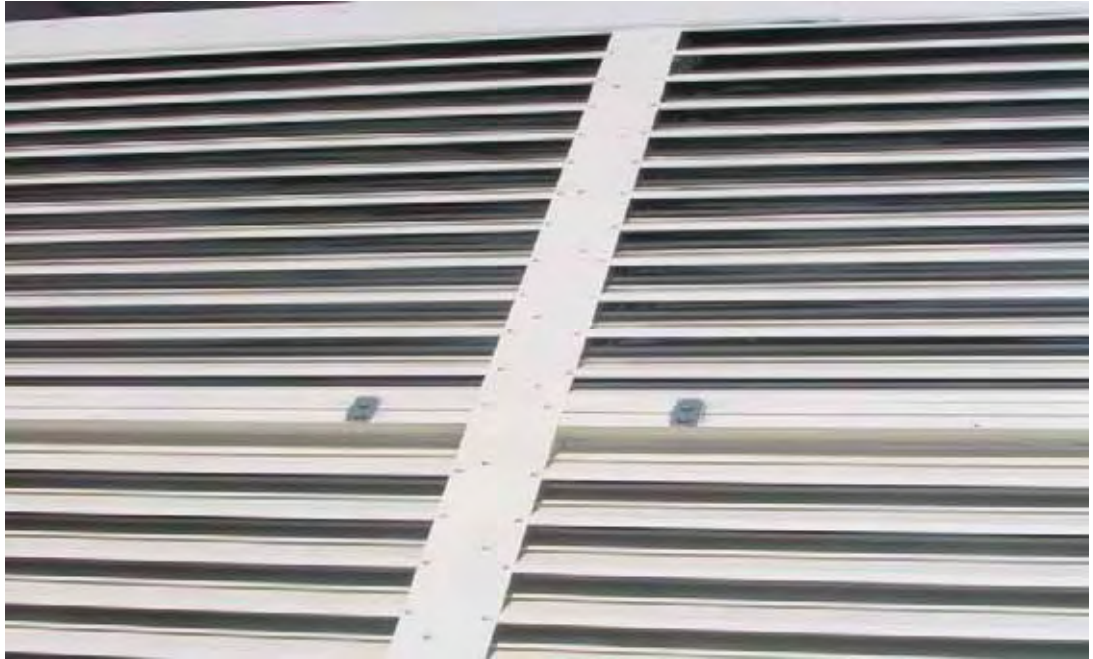
**Figure 4.58** Parapet cladding sitting over mullion face of louvres, providing additional connection for louvres; holes drilled in horizontal portion of mullions to allow entrapped water to escape.

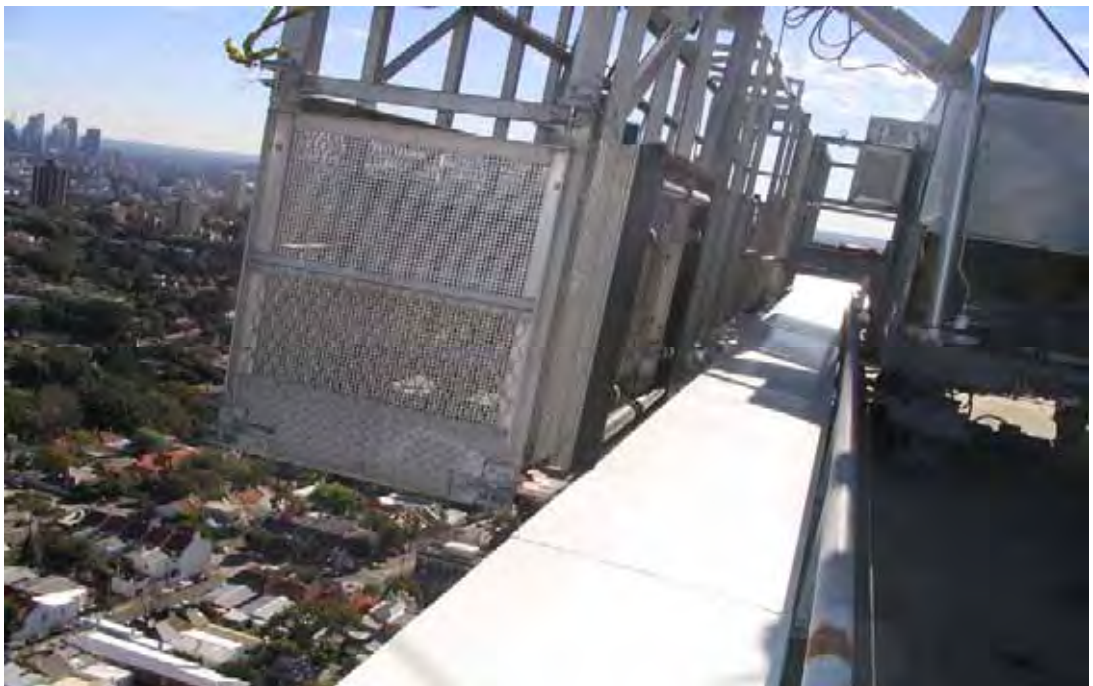
**Figure 4.59** Potential of BMU to descend posing serious structural problem for integrity and life of cladding.

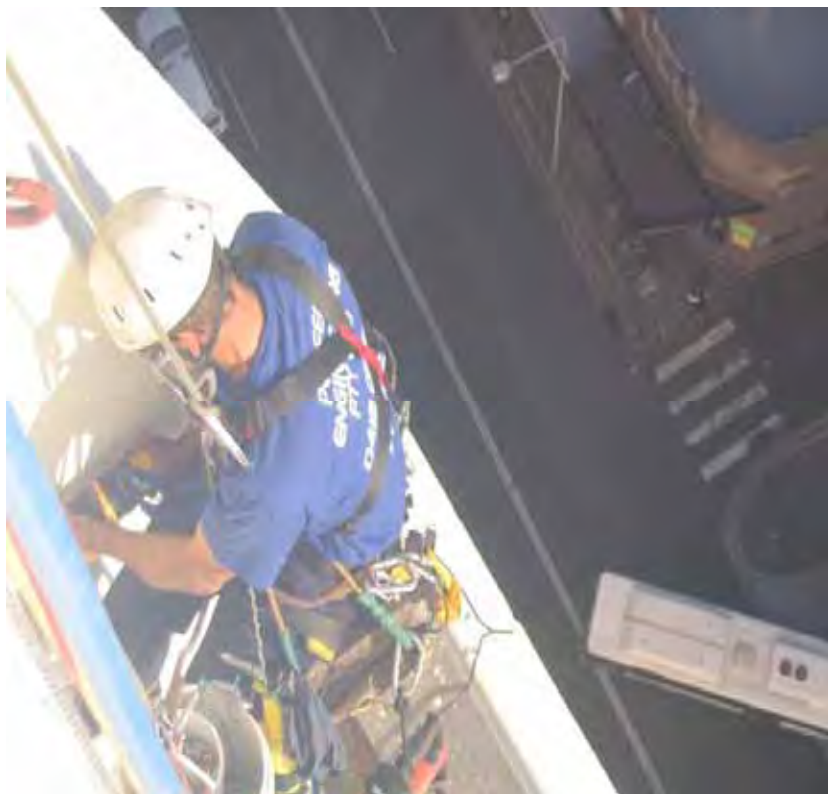
**Figure 4.60b** Jigs engineered so that abseilers could perform duties with relative ease.

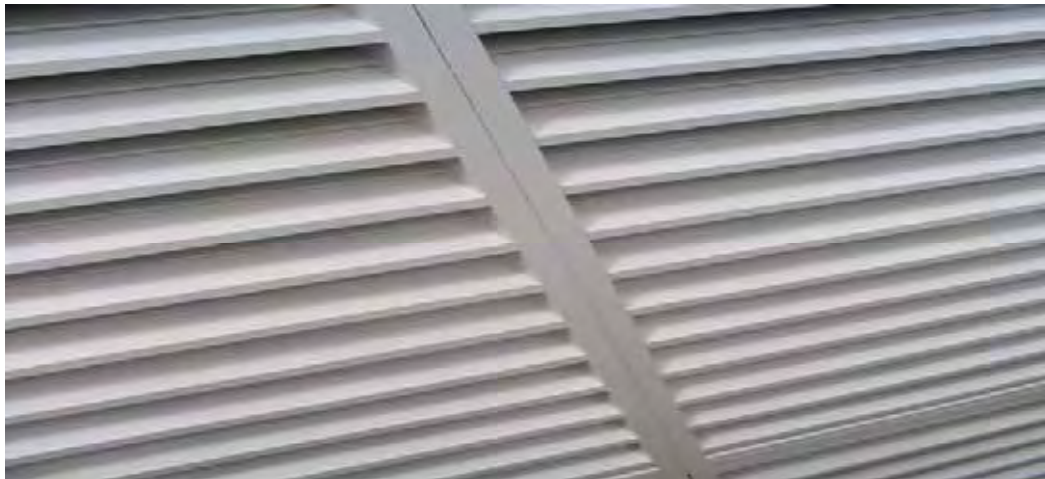
**Figure 4.61** Typical section of two main mullions side by side prior to being connected together on level 28.

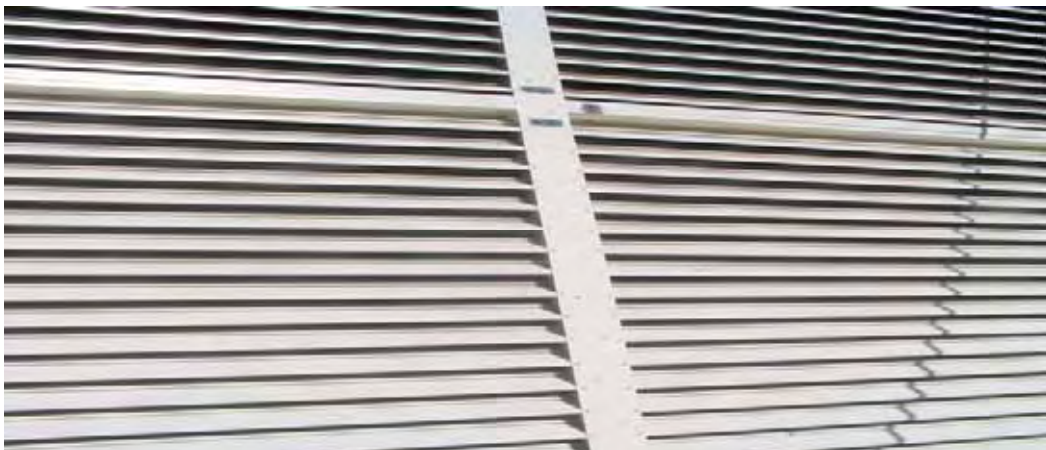
**Figure 4.62** Two mullion sections and louvres connected and held securely in place on level 28.

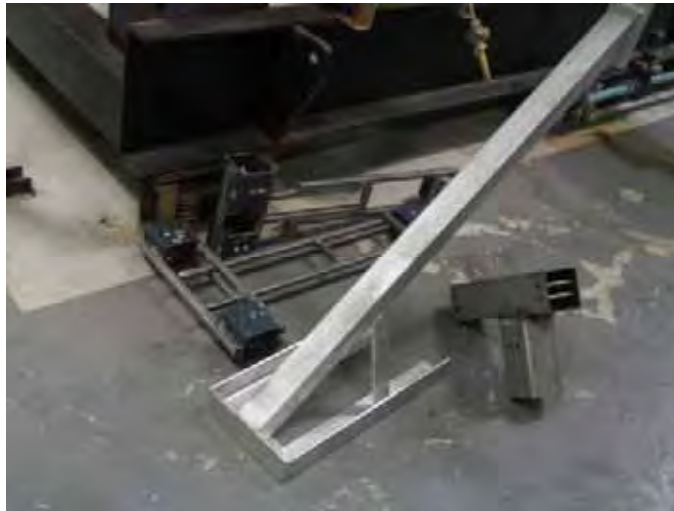
**Figure 4.63a** Special jigs engineered to allow marrying up of bolts from outside of mullions to connect through to internally fabricated brackets.

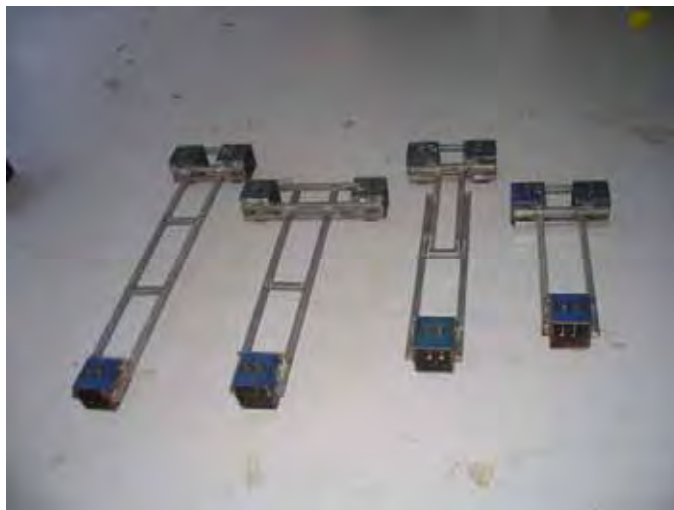
**Figure 4.63b** Jigs for bolt connection to upper U-brackets in internal of level 28.

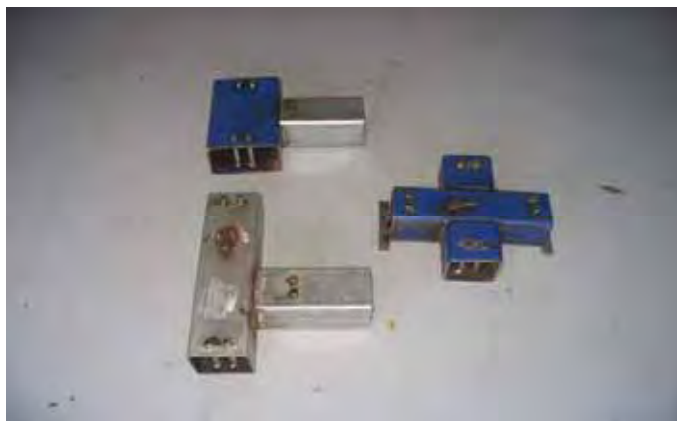
**Figure 4.63c** Jigs for bolt connection to lower C-brackets in internal of level 28.

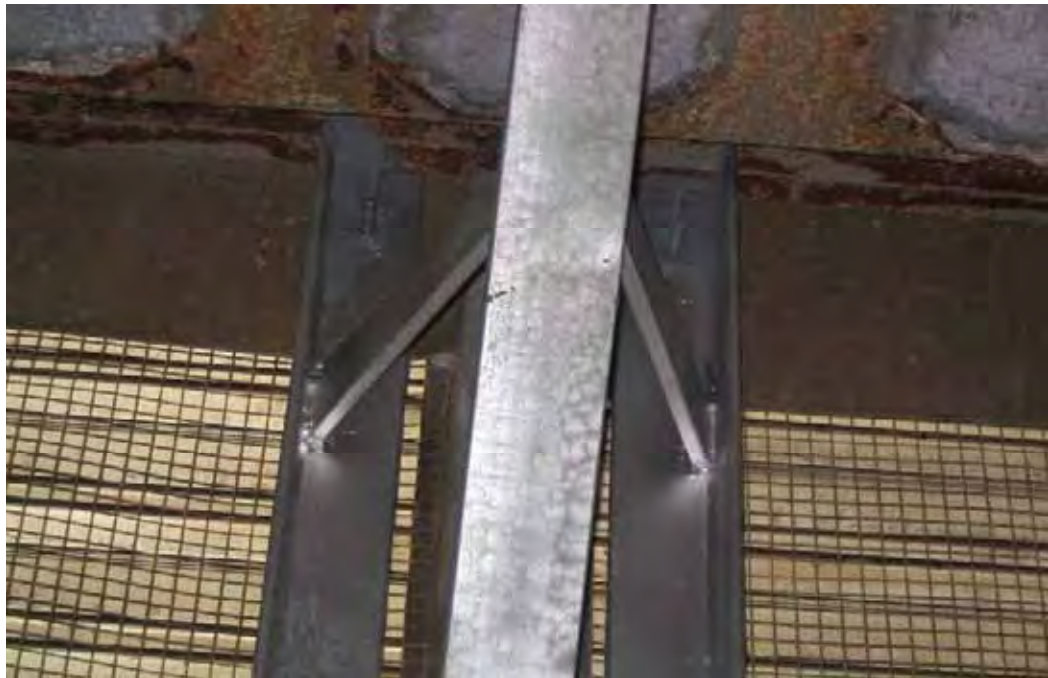
**Figure 4.65b** Upper U-bracket connecting mullion in internal of level 28 using bolts specifically threaded to account for extra length, enabling abseilers to use specially made jigs to drill through mullions and bolt directly through welded nut on brackets.

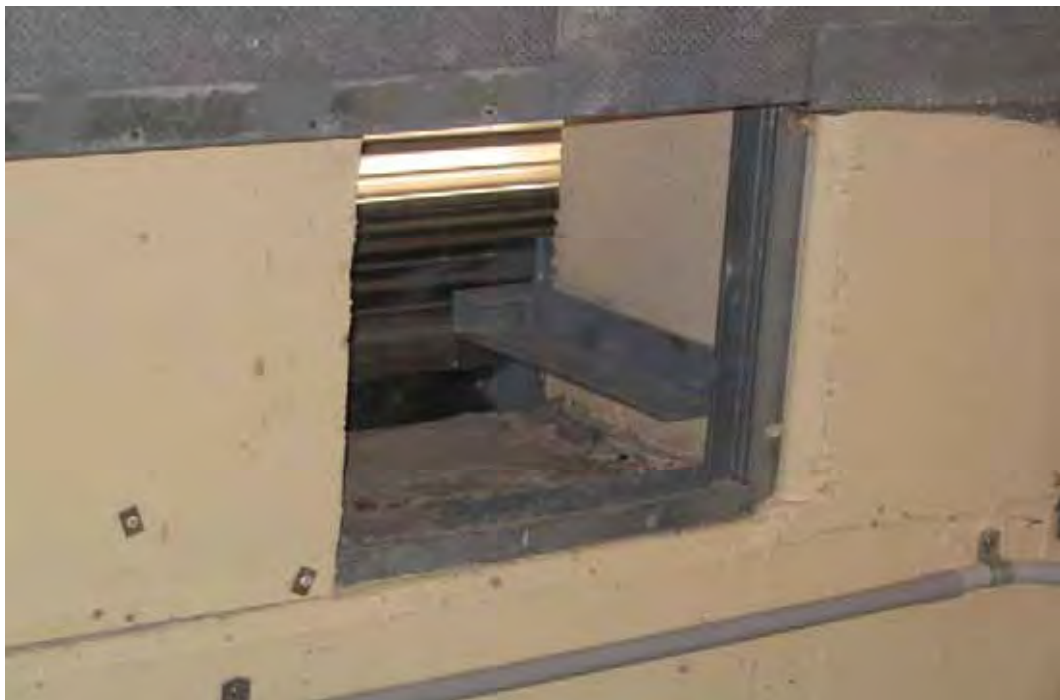
**Figure 4.65d** Detail of plate (for lower bracket) sitting behind hob and awkward to access.

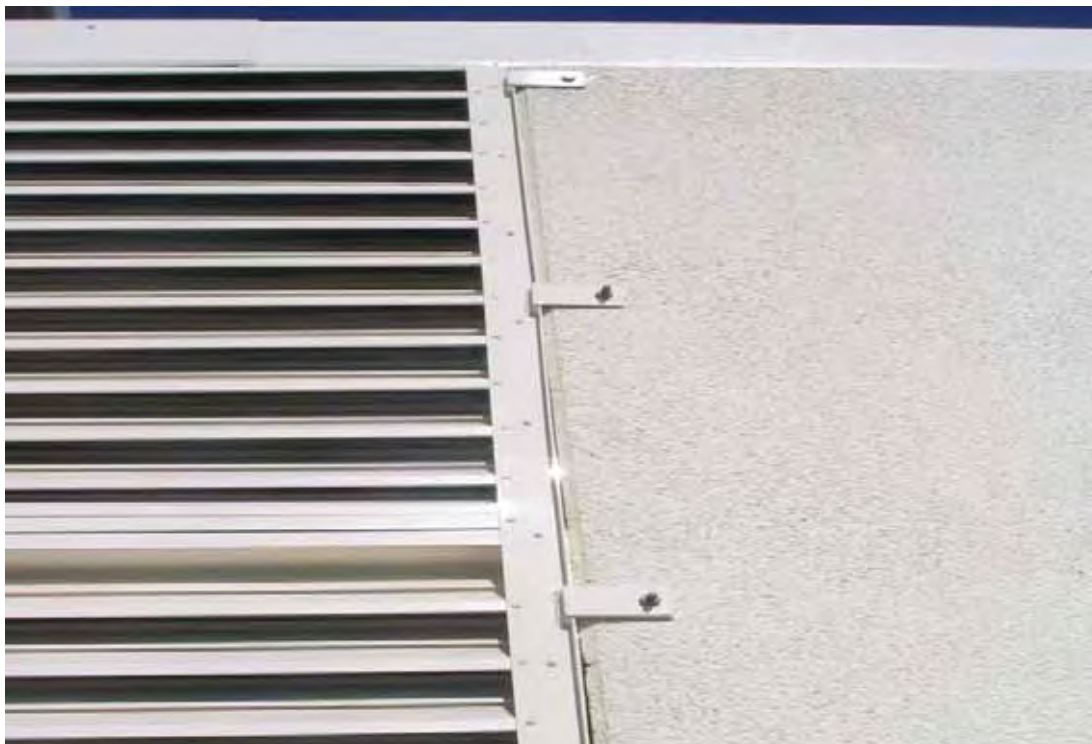
**Figure 4.66b** Aluminium unequal angle 60 mm x 25 mm x 3 mm 6060 T5 (top section) riveted to louvres and welded to unequal angle 100 mm x 50 mm x 6mm 6060 T5 brackets, which were chemically anchored in concrete wall.

One of the key issues, discussed briefly earlier, involved the brackets that support each louvre section around the building façade (see Figures 4.66a to d). The chemical anchor bolt position in these brackets was designed to give a 50 mm distance from the edge of the concrete. However, this created a conflict with the requirements set forth by *Hilti* (Appendix R). The supplier of these M10 bolts stipulated a minimal edge distance of 90 mm. This change was incorporated during site installation. However, FEA revealed undesirable stress levels in certain locations of the plate, near the drilled hole and on the angle, as will be discussed later.

the tight time constraints placed by Westfield, which conflicted with the requirements of the QA system, which would have required a minimum of at least 2 days before work with these components could have been approved. From Figures 4.66a to d, it can be seen that wind loading would apply two types of force to the louvre system:
