# Design variables for steel and aluminium in high-rise rooftops

# **Design Variables for Steel and Aluminium in High-Rise Rooftops**

This dissertation reports a case study in the design and construction solutions for a major corrosion failure of the aluminium louvres and steel brackets on the roof and façade of levels 26-29 of the Westfield Tower 2, Bondi Junction. This work was undertaken during early 2005.

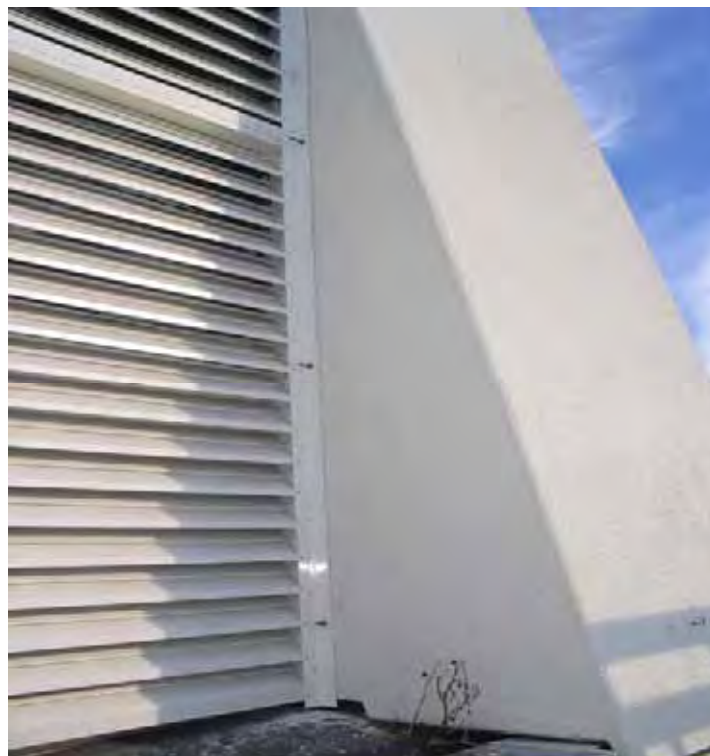
**Figure 4.66c** Sketch of aluminium equal angle 60 mm x 60 mm x 3 mm 6060 T5 (bottom section) chemically anchored to concrete wall and secured to louvre panels using riveting.

One of the key issues, discussed briefly earlier, involved the brackets that support each louvre section around the building façade (see Figures 4.66a to d). The chemical anchor bolt position in these brackets was designed to give a 50 mm distance from the edge of the concrete. However, this created a conflict with the requirements set forth by *Hilti* (Appendix R). The supplier of these M10 bolts stipulated a minimal edge distance of 90 mm. This change was incorporated during site installation. However, FEA revealed undesirable stress levels in certain locations of the plate, near the drilled hole and on the angle, as will be discussed later.

the tight time constraints placed by Westfield, which conflicted with the requirements of the QA system, which would have required a minimum of at least 2 days before work with these components could have been approved. From Figures 4.66a to d, it can be seen that wind loading would apply two types of force to the louvre system:

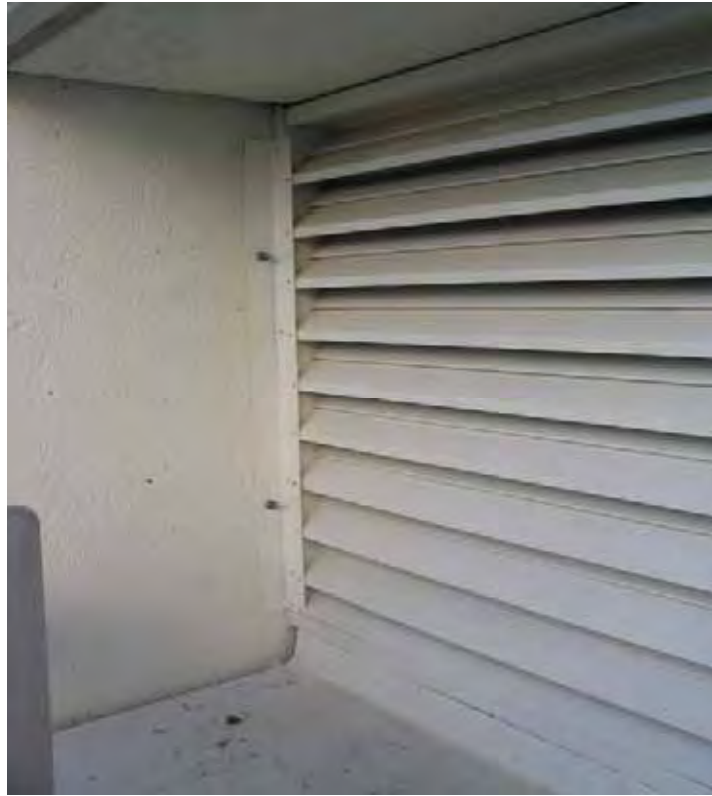
**Figure 4.66d** Aluminium equal angle 60 mm x 60 mm x 3 mm 6060 T5 (bottom section) chemically anchored to concrete wall and secured to louvre panels using riveting.

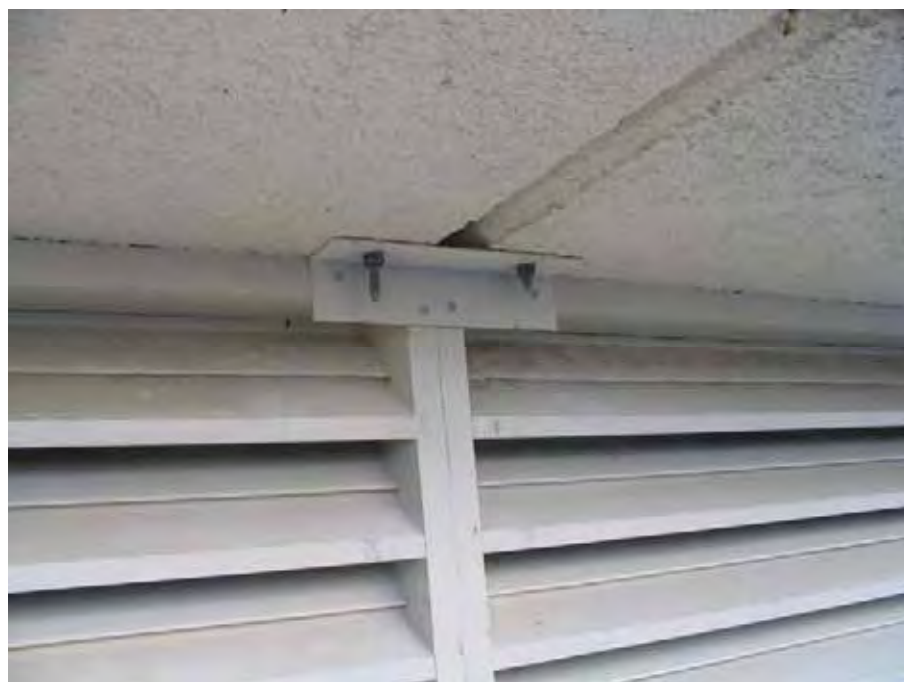
**Figure 4.66e** Aluminium equal angle 60 mm x 60 mm x 3 mm 6060 T5 chemically anchored to concrete wall and secured to louvre as in levels 27 and 28.

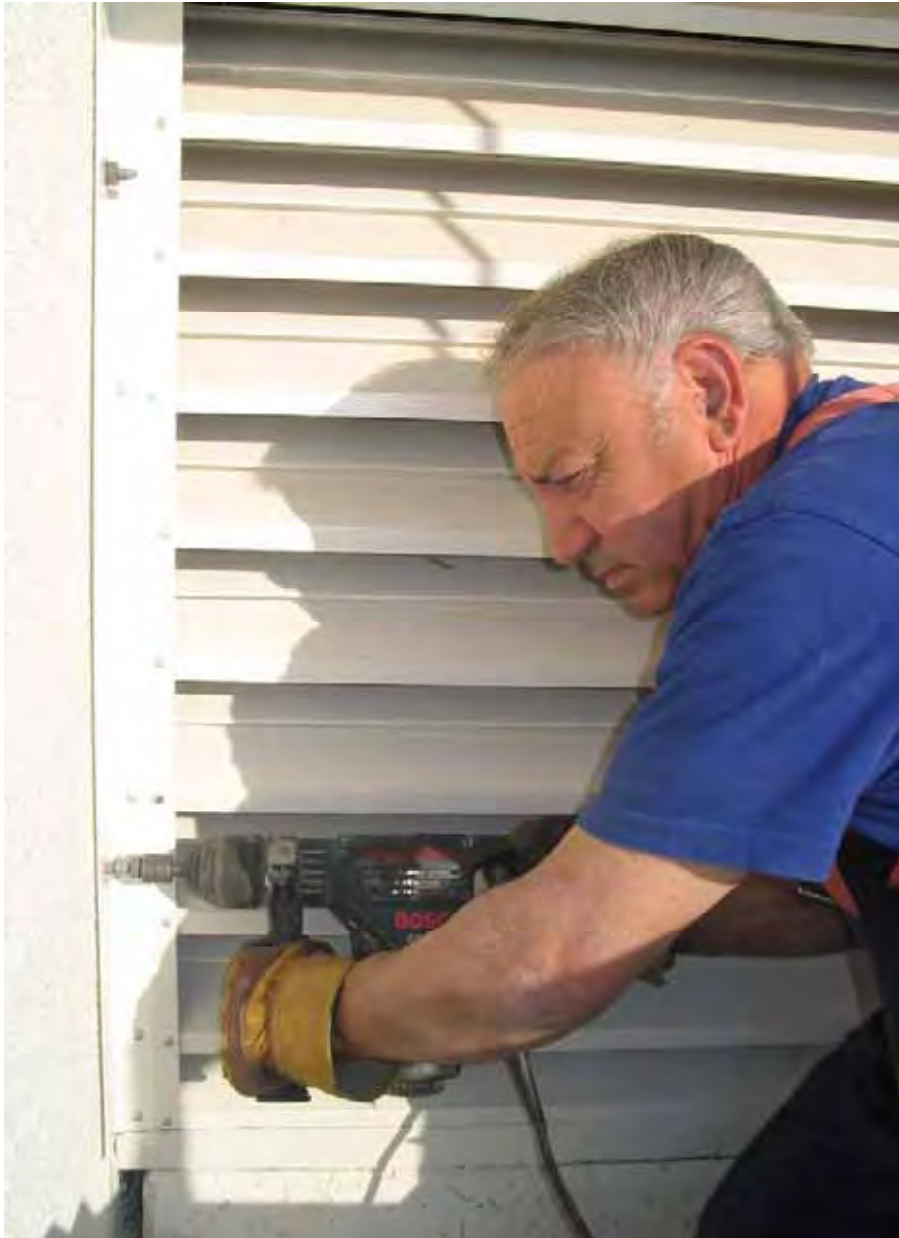
**Figure 4.67** Aluminium equal angle 60 mm x 60 mm x 3 mm 6060 T5 chemically anchored to concrete roof to hold louvre mullion sections in centre.

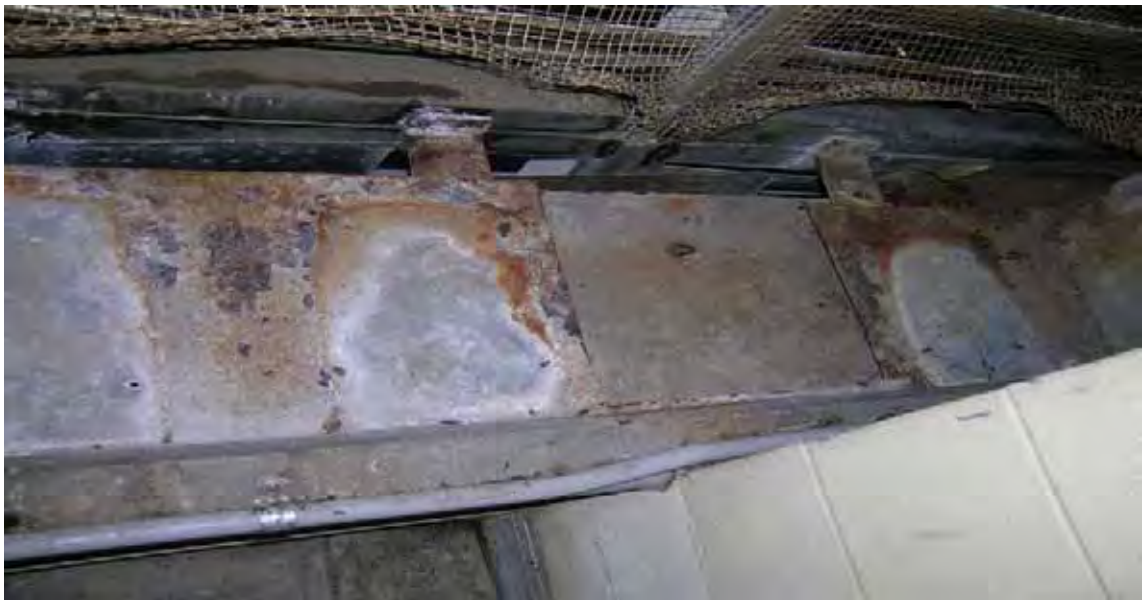
**Figure 5.1** Slope as function of resultant factors in Table 5.3; calculated.

This figure can be useful to designers because it allows a comparison of the conditions that can be designed with corrosion-resistance in mind. For example, if it is desired to build a structure with a moderate lifespan dictated by corrosion, then a severity factor of 0.5 might be selected. In Figure 5.1, this can be identified and a vertical line drawn at that point. Table 5.6 also can be used to identify the intersections with this vertical line, which occur at:

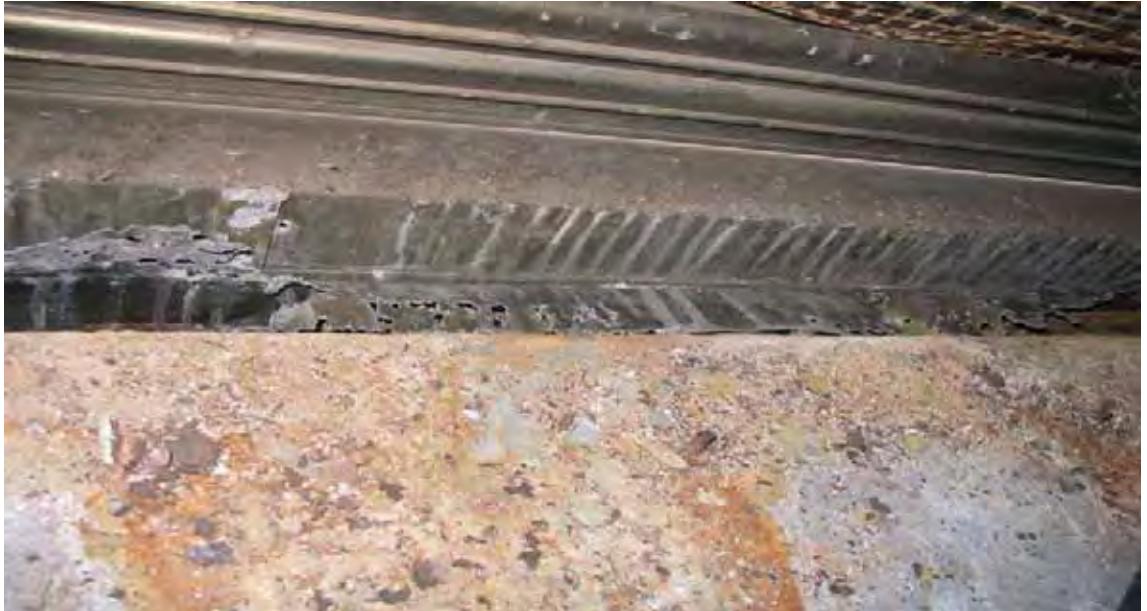
**Figure 5.2** East (E2); left bracket centre; full cover from roof, exposed to westerly winds.

Concerning the effects of orientation and barriers, Figures 5.2 to 5.5 show how these effects can vary, despite being treated as constants for the entire building in terms of the macro-climate:

- a) *Figure 5.2:* Baffle bench on east side, level 28, under full roof cover, partially exposed to westerly winds; minor corrosion
- b) *Figure 5.3:* Baffle bench on east side, level 28, under full roof cover, fully exposed to westerly winds; major corrosion
- c) *Figure 5.4:* Baffle bench on north side, level 28, fully covered and enclosed by four walls but with exposure through louvres; slight corrosion
- d) *Figure 5.5:* Baffle bench on south side, level 28, fully covered and partially protected by plant and semi-wall; moderate corrosion

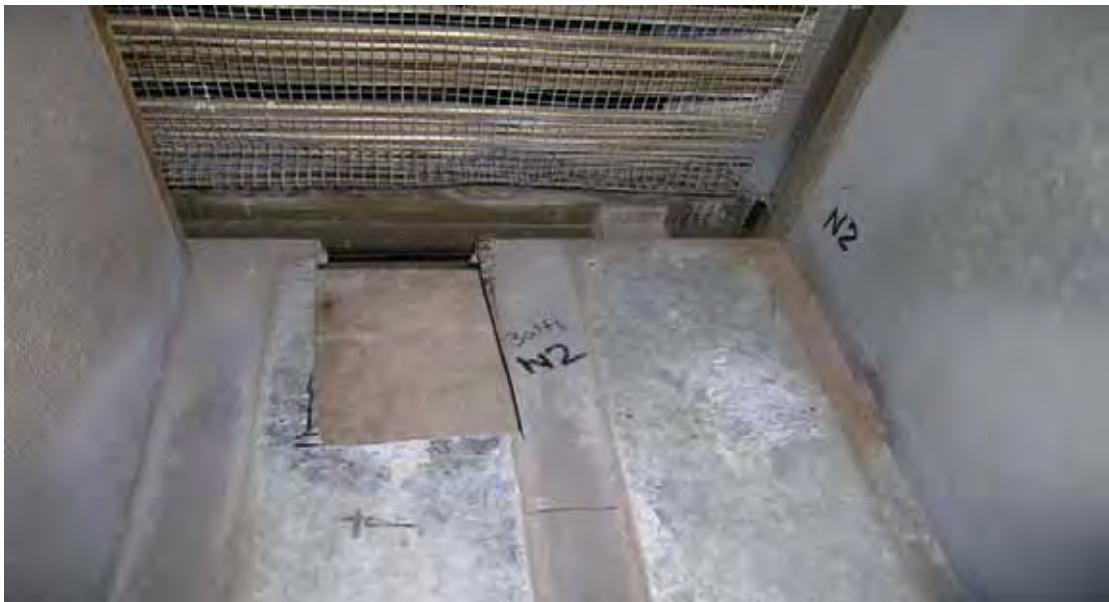
**Figure 5.4** North (N2); level 28, showing condition of both baffles on sides and louvre in centre in nearly acceptable state; fully covered; all sides fully enclosed by concrete walls; only open position from louvres facing outside; resulting in no corrosion.

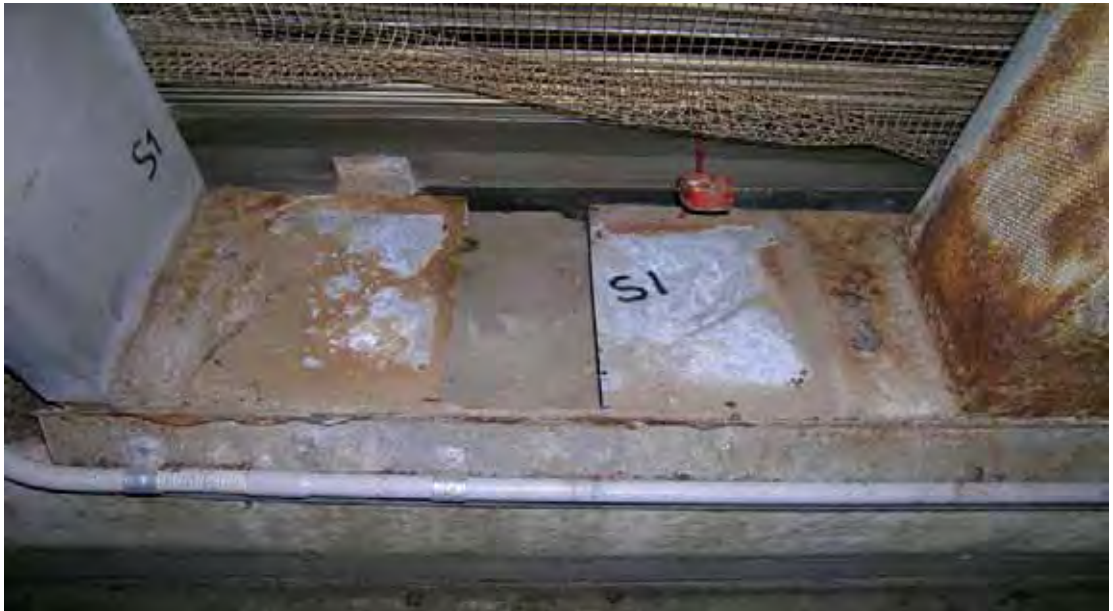
**Figure 5.5** South section; fully under cover; with plant in front; corrosion commencing; westerly wind impinging on plant in front of section and on semi-wall in front of section, protecting it from excess airborne contaminants.

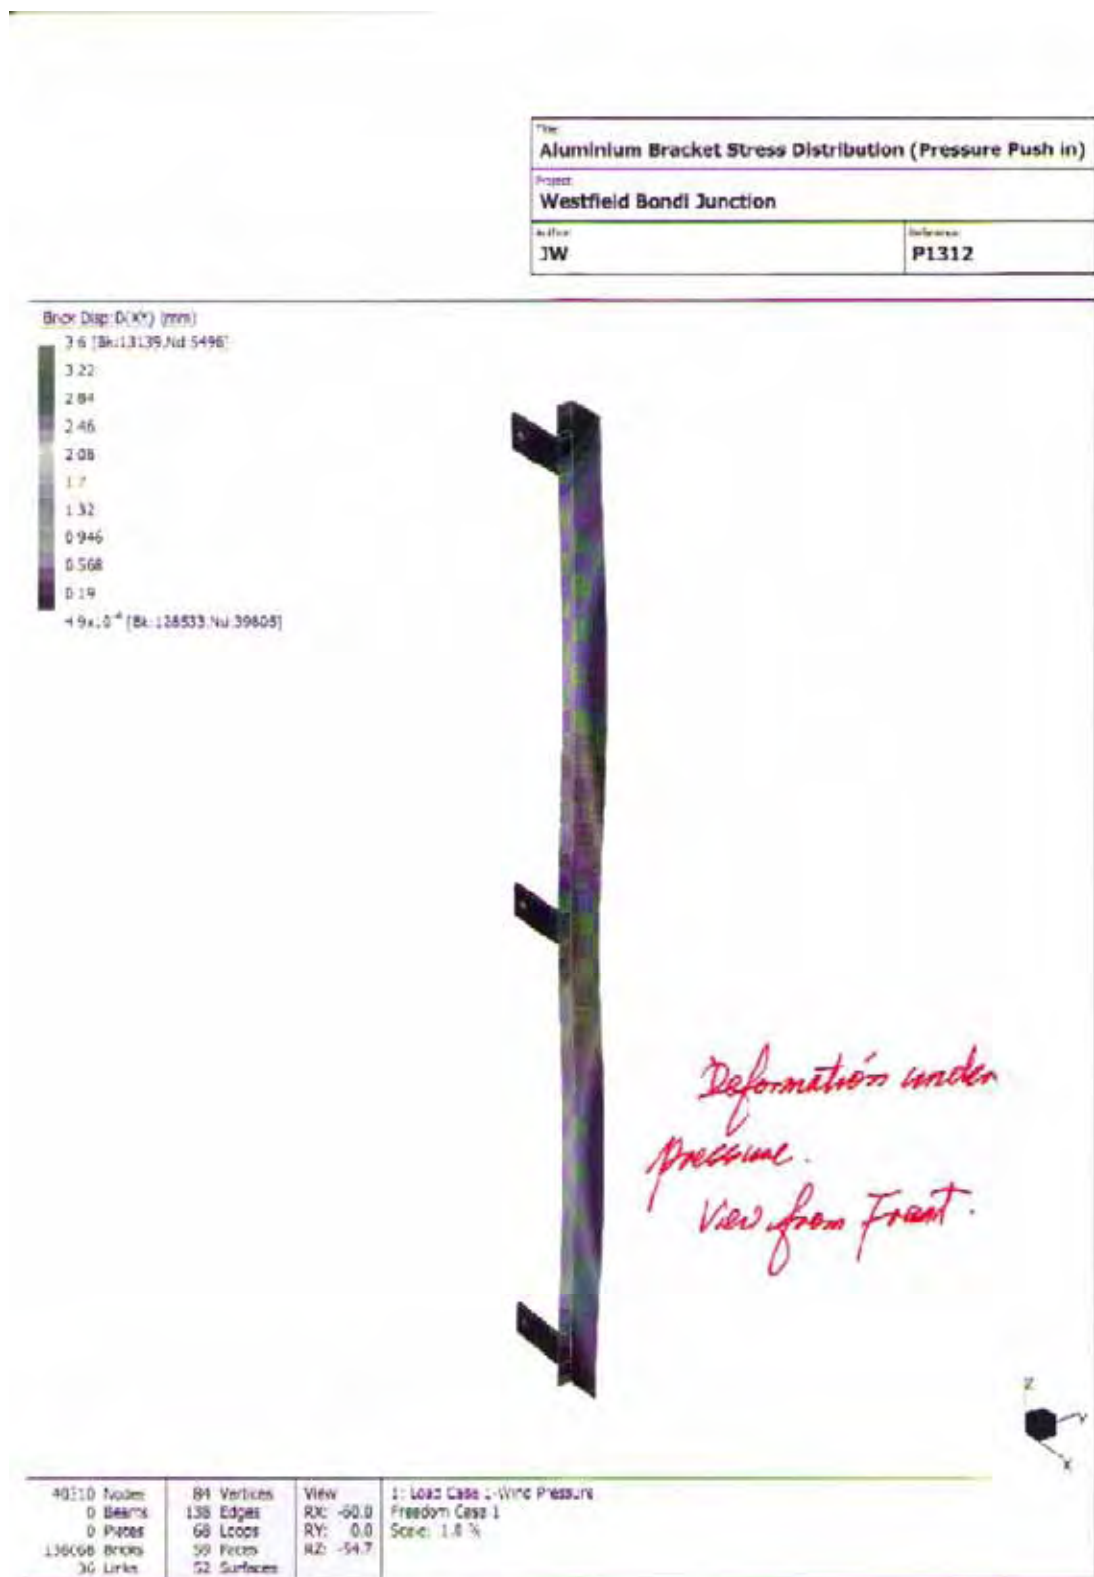
**Figure 7.8** FEA illustrating maximal stress distribution against wall due to suction forces' attempting to lift bracket from wall; imposition of resultant excessive load on bolt on opposite side.

has the wall exerting an equal and opposite reaction to it. The reason the bracket was severely overstressed under suction is that the bolt hole was 20 mm away from the edge of the plate, thus placing stress on the plate in the region where the bolt mates with it when inclined (see Figure 7.8).

Figure 7.6 Illustrates buckling under suction, as viewed from the back of the louvre face. Figure 7.7 illustrates the maximal stress distribution around the bolt region due to suction forces, as viewed from the face of louvres. Figure 7.7 shows the maximal stress distribution against the wall due to suction forces' attempting to lift away the bracket from the wall. As a result, an excessive load is exerted on the bolt on the opposite side, as shown in Figure 7.8. Figure 7.9 indicates buckling due to pressure forces, as seen from the face of the louvres. Figure 7.10 illustrates the general stress stress distribution due to the pressure forces, as seen from the face of the louvres. Figure 7.11 shows the maximal load stress distribution due to the pressure forces, as seen from the face of the louvres, acting in the vicinity of the weld region.

Concerning the plate bracket, as mentioned earlier, the 6060 T5 aluminium plate was altered at two main locations, as clearly shown by the FEA results in Figures 7.8 and 7.11. Also, it can be seen that the FEA results indicated high levels of stress in the vicinity of the welded region. The FEA calculations take into account as a general rule of thumb a distance of ~1 inch (25 mm) away from the weld as being the HAZ, which is compensated in the calculations by a multiplication factor of 0.75.

The interesting aspect of these calculations suggests that, if the bolt were to remain in its original position of 50 mm from the concrete edge, then the actual force on the plate would have been distributed more uniformly and, as a result, the force would not have been concentrated, as shown in the FEA data in Figure 7.8.

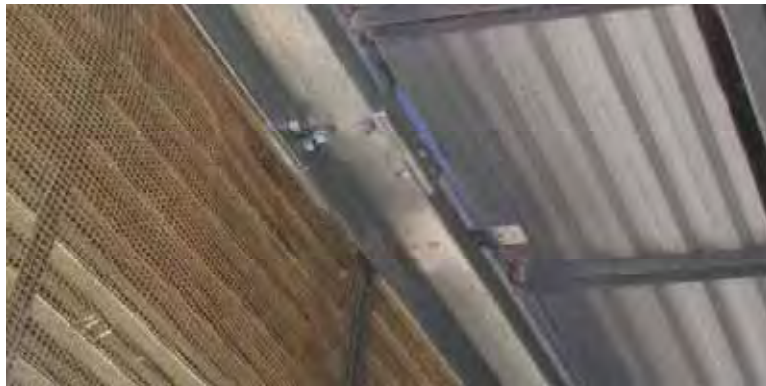
4.3m span

(New beam all along the Eastern face (See appendix A).

$$= 3.2 \times 2/3 = \underline{2.1 \text{ kN/m}} \text{ (service)}$$

Max deflection at mid span.
