Health and flight safety implications from exposure to contaminated air in aircraft

Author: Michaelis, Susan

A thesis submitted in fulfilment of the requirements for the degree of Master of Doctor of Philosophy School of Risk and Safety Sciences Faculty of Science The University of New South Wales

September 2010

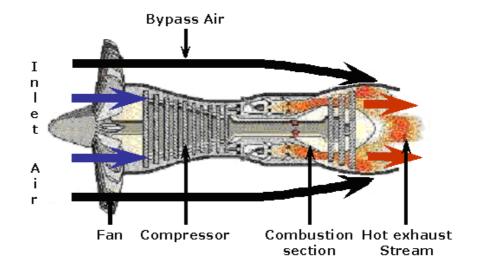
Figure 2-3: Schematic of the air flow in a modern jet engine

Currently pressurising the aircraft and providing an air supply to the passenger cabin and cockpit, is achieved by taking 'bleed air' from within the engine and feeding this into an Environmental Control System (ECS). Figure 2-3 shows the cutaway diagram of a jet engine. This is a view looking sideways at the engine. The 'Inlet Air' from the atmosphere is the outside air and as it enters into the engine it either bypasses the core or centre part of the engine, in which case it is known as 'Fan Air' or 'Bypass Air', or it enters the core of the engine where the air is compressed within the compression section of the engine before entering the combustion section of the engine. In the combustion section jet fuel is added to the compressed air which accelerates out of the back of the engine as hot fast moving air.

The exhaust air also drives several turbines which turn the compression and fan sections of the engine. Typically, about 75% of the thrust of a normal bypass gas turbine engine is produced from the main front fan of the engine. The other 25% is produced from the exhaust gases.

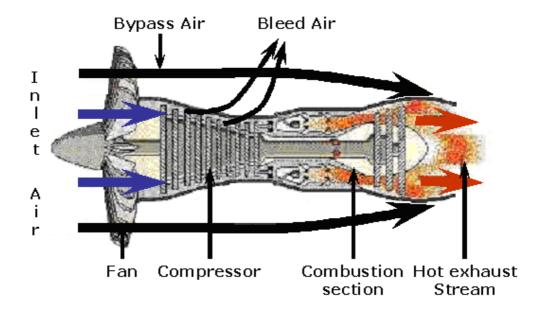
The majority of the air entering the core of the engine passes on to the combustion section but some of the compressed air, typically 2-8%, [135] is 'bled off' as 'bleed air' which can be taken from specific compression stages of the compressor section of the engine as designed by the engine manufacturer. The location of the bleed air port(s) on the engine will be dependent on the pressure or temperature required for a particular task or stage of flight. Engines are usually designed with a low and high stage pressure bleed air take off point within the compression section of the engine because as thrust increases the pressure within the compression (and temperature) section of the engine also increases. Therefore, at high power settings the bleed air will normally be taken from the lower pressure take off point reverting back to the high pressure take off point when the pressure at the low pressure point decreases below a predetermined level. Bleed air is normally extracted from the low stage compressor port, however when engine power is below the level at which the low stage meets the 'using systems needs', the high pressure stage is then utilized. [136] At low engine power settings, the high stage air is the only source of air sufficient to meet the needs of the bleed system. [137] That is, the high stage port is required when the air coming off the low/intermediate stage is not adequate, or a considerable amount of air is necessary and the engine is being operated in conditions that cannot be deteriorated by intensive air bleeding, typically during taxiing, take off and descent with the engine near idle. [135] Bleed air is extracted at the lowest practical temperature/pressure to meet system needs (aircraft pneumatic services) at best economy, whilst limiting the temperatures to which the air is heated by using (in most cases) the multi stage bleed extraction system. [137,138] The use of the low stage air is used to the maximum extent possible with it's inherent savings in aircraft performance penalty encountered with use of higher stage air. [138] The air which is 'bled off' from the engine is done so before the compressed air enters the combustion section of the engine as shown in Figure 2-4.

The design of the bleed air system for cabin air is different for different engine and APU types. [139] In some constructions the air is extracted far forward on the engine where the compressor air is not so hot and where oil leakage from a bearing casing may or cannot end up in the bleed air system. [139] In other engine constructions, the air is extracted farther back in the compressor 'where both pressure and temperature are higher and the risk of leaking oil possibly finding it's way out via the bleed air is greater.' [139] The engine used on the BAe 146 (ALF 502/507) takes the air from a single (does not use low and high stage ports) output of the HP compressor located (ring formed duct) on the combustion case shroud aft of the compressors. On most modern jet engines, the bleed air outlet is located farther forward on the engine, i.e. somewhere on the compressor section of the gas generator. [139] Additionally on most jet engines the air is bled from the intermediate (IP) or low stage (LP) compressor stages in addition to the high stage (HP) at certain engine operations. Depending on the thrust settings of the engine in question, the temperature of the bleed air will vary. A bleed air port can be clearly seen in Figure 2-5.

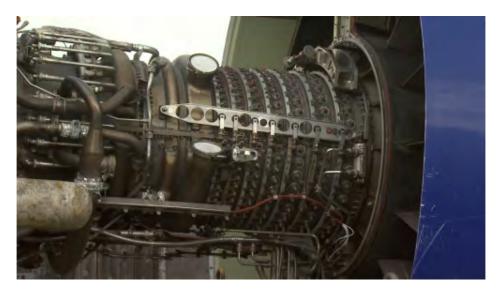
Figure 2-5: Bleed air ports on high bypass gas turbine engine

When the bleed air leaves the compression section of the engine it is very hot. Temperatures reported in the high stage compression section of an engine can be in the region of 300 to 650°C, yet in the intermediate (low stage) compressor they will be considerably lower between 50 and 300°C. [140] The bleed air used on the BAe 146 is said to range between 100 and 400°C. [139] Therefore, the air must be cooled before entering the passenger cabin or cockpit. Cooling is done usually initially by a heat exchanger such as a *'pre-cooler'* which are located in the engine struts cooling the air down to around 200°C and then, after flowing through ducting in the wing, enters the *'Air Conditioning Packs'* or 'A/C *pack.'* [141]

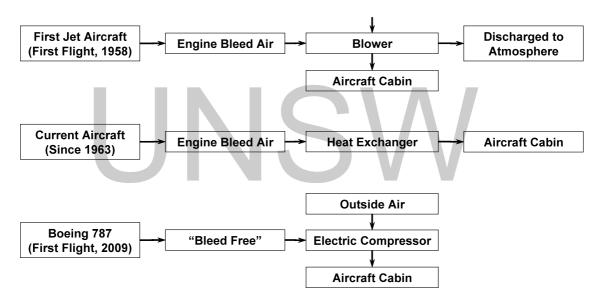
Figure 2-7: Bleed Air Path

The difference between the use of bleed air to supply the passenger cabin and cockpit directly, compared to the use of the bleed air to operate compressors and blowers, which independently provided outside air necessary for the aircraft is shown in Figure 2-7.

While all the air from the engines of early turbojet aircraft went through the core, fuel consumption was very high, however the additional fuel required to provide outside air to the cabin was very small as the bleed air extraction was a small percentage of the total core airflow. [137] Turbofans were then developed using initially core bypass ratios of around 2 to 1, which improved fuel economy and the cost of engine bleed air relative to overall fuel consumption was still relatively small to make using 100% bleed air direct into the cabin cost effective. Lower direct fuel costs and shorter sector lengths also played a role here. As higher bypass ratios engines were developed, fuel consumption to provide engine thrust reduced, however the fuel consumption to extract bleed air increased 'dramatically'. [137]

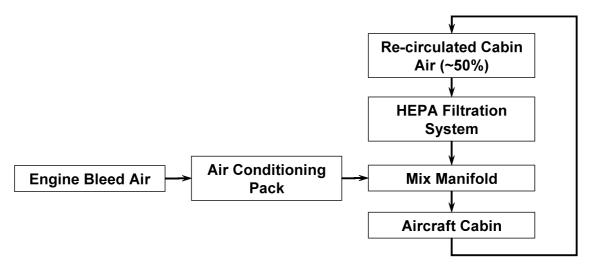
Figure 2-9: Flow Chart of Recirculated Air

The re-circulated air-filtration systems are placed beside the Mix Manifold so that the cabin air that is to be re-circulated passes through the air-filtration system before it enters the Mix Manifold where it is the mixed with the incoming unfiltered outside air. A simplified flow chart (see Figure 2-9) shows a typical air supply system used today on commercial jet aircraft. Only the re-circulated air is filtered by HEPA filters. The Bleed air is not filtered and it is through bleed air that contaminated air enters the aircraft.

HEPA filters used for the re-circulated air provide a minimum capture efficiency (most penetrating particle size) at about 0.1 to 0.3 micron particle size, however

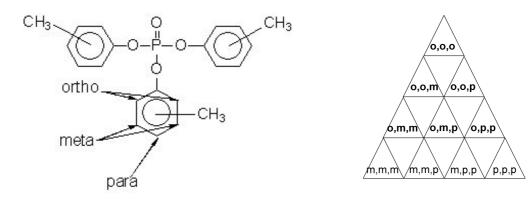
Figure 2-10: Isomers of tricresyl phosphate

TCP is a molecule comprising three cresyl (methylphenyl) groups linked to a phosphate group. The location of the methyl group in the cresyl group is critical for the expression of neurotoxicity, with ortho-, meta- or para- prefixes that denote how far apart the hydroxyl and methyl groups are on the cresol molecule. There are in fact 27 different combinations of the meta, para and ortho groups in TCP, however, numerous combinations are considered the same molecule such as ppm, pmp, mpp as they are optical isomers of each other. Therefore, there are in reality ten isomers of TCP that are conventionally described as shown in Figure 2-10. [182]

TCP molecule showing o- (ortho), m- (meta), Possible isomers of TCP. * and p- (para) cresyl groups.

* ortho-cresyl group containing molecules are highlighted in **bold**

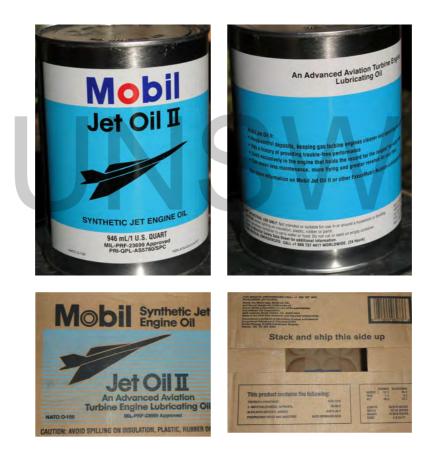
Figure 2-11: Mobil Jet Oil II labelling

As MJO II should be listed as a hazardous substance, the above labelling does not follow the NOHSC guidelines and therefore fails to identify to the user what the substances are and what significant hazards may be involved. [91,98]

The labelling requirements closely follow the MSDS requirements. It is noteworthy that the cardboard packaging that the cans of oil are delivered in states the product contains Tricresyl Phosphate (1330-78-5); 1-Napthalenamine, N Phenyl (90-30-2); Alkylated diphenyl amines (68411-46-1); Proprietary ester and additives. The previous label contained at least some of

the required warnings and the size of the container does not warrant the label excluding the contents and necessary warnings, deferring to the cardboard packaging (see Figure 2-11 on previous page).

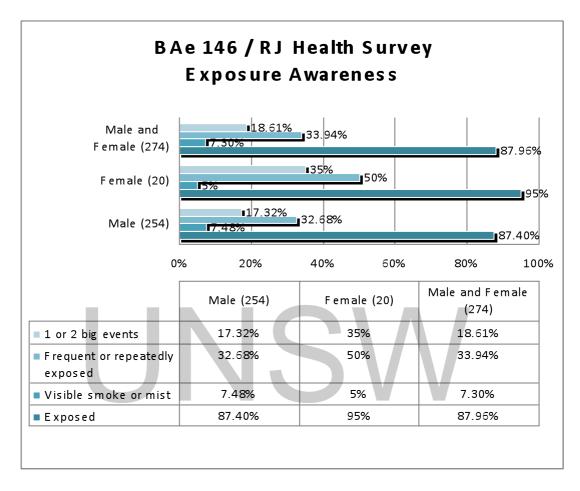
Figure 4-8: Exposure awareness

Figure 4-8 identifies crew awareness of exposure history. 88% (241) of those contacted advised they had been exposed to contaminated air. While the majority was identified as oil related, there were a few reports of exposure to

hydraulic fumes and deicing fluid fumes. 95% of the females contacted advised awareness of the contaminated air while the rate was 87% for the males. 91% of all those contacted were aware of the cabin air contamination issue.

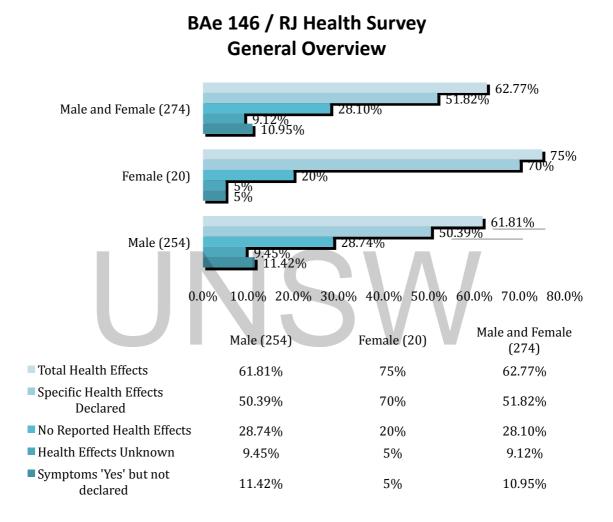
88% of crews contacted reported a confirmed exposure history to contaminated air with 63% of the respondents reporting adverse health effects as shown in Figure 4-9.

Specific declared health effects were reported by 52% (142) of those contacted, with a further 11% (30) reporting they had experienced adverse effects but did not identify them. Heath effects were unknown in 9% (25) of crews while 28% (77) advised they had not experienced any adverse health effects that might be related to their flying environment or exposure to contaminated air.

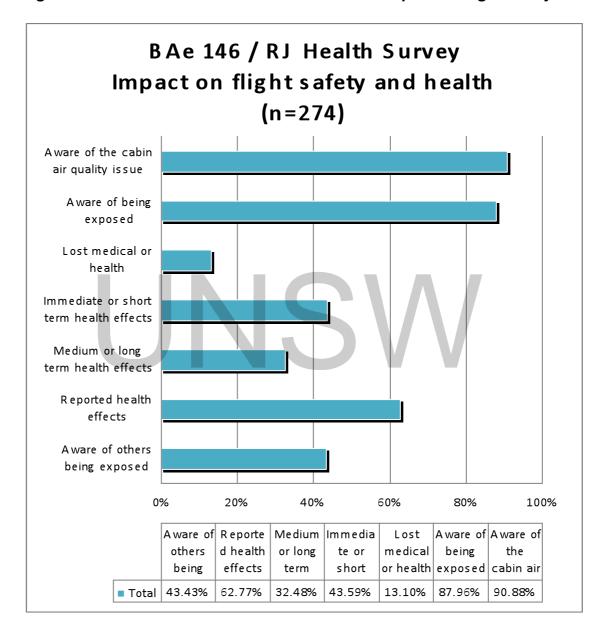
44% (120) of those contacted reported immediate or short-term adverse health effects (Figure 4-10) immediately after or shortly after exposure to contaminated air.

Figure 4-10 and Figure 4-11 both show the onset of symptoms in further detail. With reported 88% exposure rate to contaminated air, 63% reported adverse health effects of some sort, ranging from immediate through short-term, medium term to long-term effects. These were assessed at:

adverse effects related to flight. Therefore as shown in Figure 4-10, data shows that 44% of pilots reporting adverse effects immediately or shortly after flight is seen as a further important source of data on impairment in flight or soon after flight with significant implications for flight safety. The addition of cabin crew impairment would significantly elevate this figure.

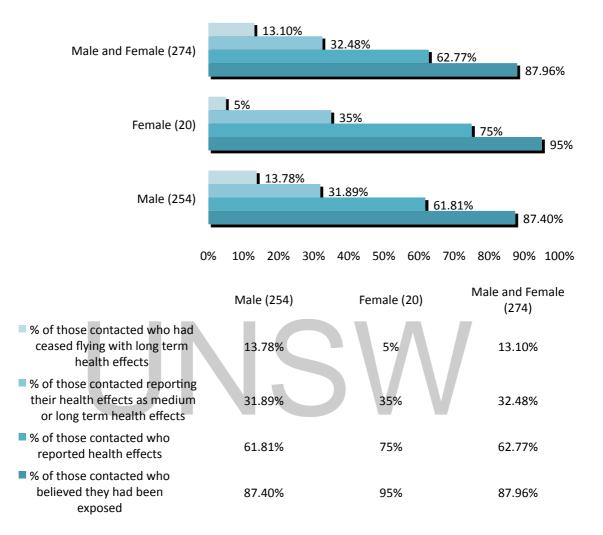
Figure 4-11: BAe 146/146 RJ Reported medium or long term health effects

BAe 146 / RJ Health Survey Medium / Long term health effects (n=274)

Figure 4-11 provides a breakdown of males and females; however it is considered that the population of females was too small to provide meaningful data with data available supporting overall consistent health effects between male and females.

Figure 4-11 reviews reported medium to long-term effects in BAe 146 crew. 32% of those contacted reported medium or long-term health effects that they either related to the cabin air exposures or which fell into a pattern of reported effects that are identifiable with exposure to contaminated air as shown in Figure 4-11.

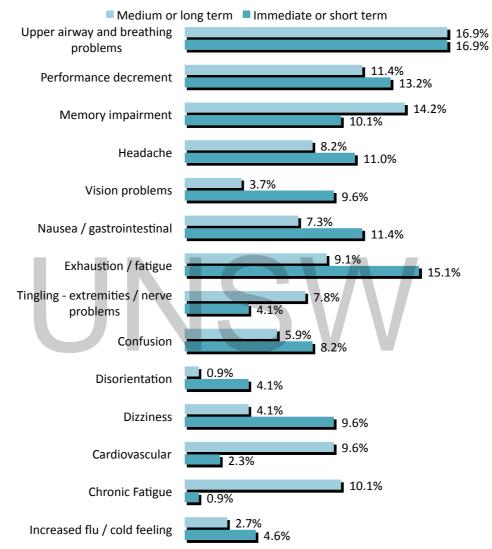
Figure 4-12: Symptom clusters in 219 BAe 146/146 RJ pilots

BAe 146 / RJ Health Survey Immediate/short term v medium/long term health effects in 219 pilots who declared specific health effects (n=142) or no health effects (n=77)

The data refer to selected symptoms only and cannot be classified into groups due to the overlap in respondent reporting. These data refer to the 142 pilots who advised specific effects. The data from the 219 pilots (Figure 4-12) will be looked at first followed by the data from the 142 pilots group (Table 4-7, Figure 4-13, Figure 4-14 and Figure 4-15).

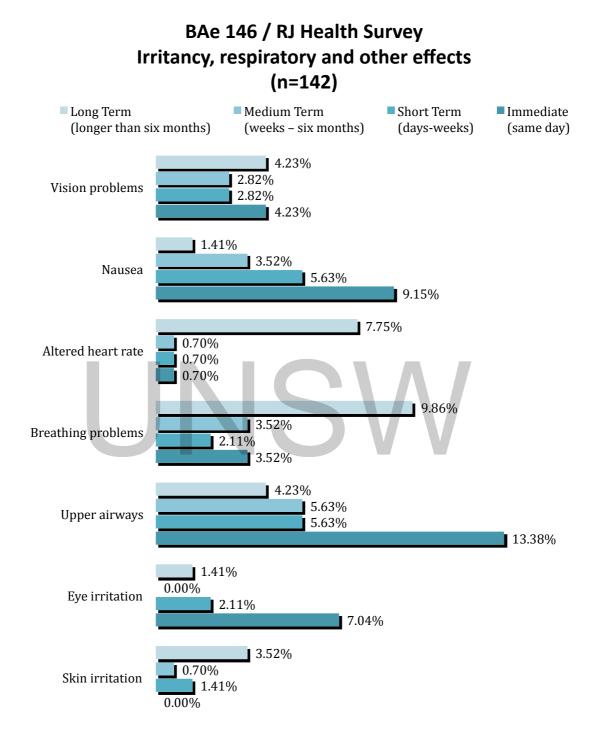
Figure 4-13: Selected local, respiratory and other health effects in 142 BAe 146/146 RJ pilots

Direct respiratory symptoms consistent with exposure to respiratory irritants or hazardous substances are also reported. Upper airway and breathing problems (chest tightness, wheezing, breathing problems and repetitive cough) are reported on an equal basis for immediate and short term (17%) and medium to long-term (17%). This is supported by the 142 pilots reporting upper airway problems immediately at 13%, ongoing through the short-term, medium and long term at 6%, 6% and 4% respectively. Breathing problems, on the other hand, in those reporting specific events show a reversal with more pilots reporting long-term breathing problems at 10% and around 3% in each of the other categories.

The 142 pilots reporting specific events also reported a 6% rate of repeated and ongoing chest infections, while 2% reported severe pulmonary problems in addition to the above rates.

Data on irritation to the upper airway, skin and eyes as well as respiratory, cardiovascular and vision symptoms are presented in Figure 4-12, Figure 4-13 and Table 4-7.

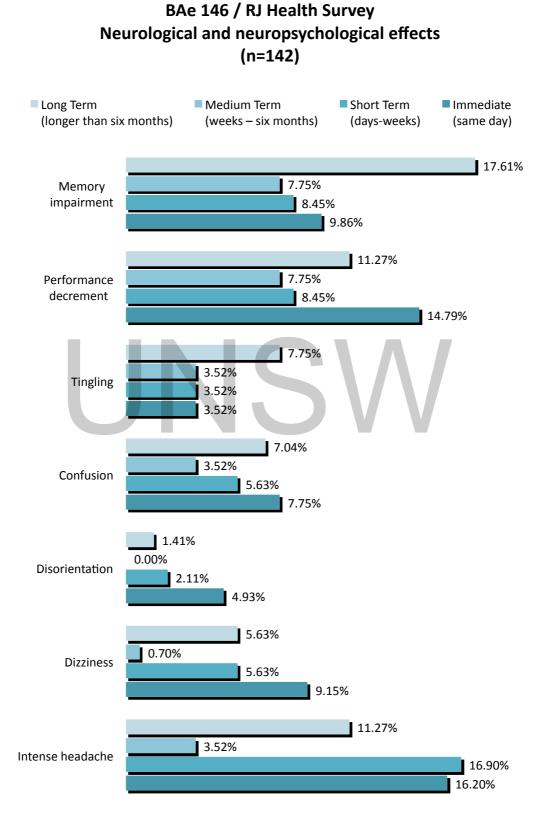
Figure 4-14: Neuropsychological and neurological health effects in 142 BAe 146/146 RJ pilots

Symptom reporting rates are highest for those reporting immediate and shortterm performance decrement (13%), followed by headaches (11%), memory impairment (10%), dizziness (10%), confusion (8%) and disorientation (4%). In the medium and long-term the one symptom that rose was memory impairment (14%) with a number showing slight increases but importantly the ongoing nature of the symptoms should be noted: performance decrement (11%), headaches (8%), confusion (6%) and dizziness (4%).

Data on neuropsychological and neurological symptoms reported in pilots surveyed are shown in Figure 4-12, Figure 4-14 and Table 4-7.

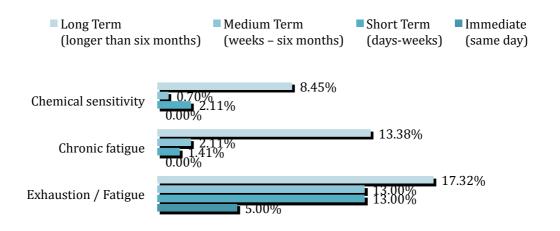
Figure 4-15: General signs and symptoms in 142 BAe 146/146 RJ pilots

Exhaustion and fatigue were reported as the main immediate and short-term symptom in the 219 pilots at 15%, with the medium and long-term rates

reported to continue on at 9%. Chronic fatigue was reported at 10% in the longer-term. In addition to symptoms and signs in specific organ systems, a range of multi organ or general symptoms was reported as shown in Figure 4-12, Figure 4-15 and Table 4-7.

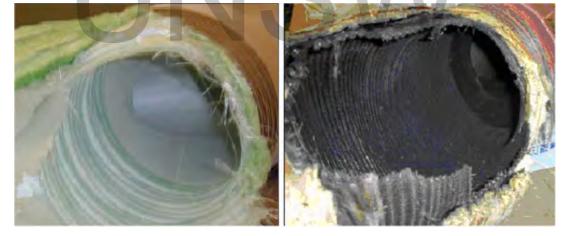
Figure 5-1: Uncontaminated and contaminated ducting

Part 2 of the report evaluated unused and contaminated cabin air supply ducts (seeFigure 5-1) removed from two different BAe 146 aircraft after flying for long periods. [94,95]

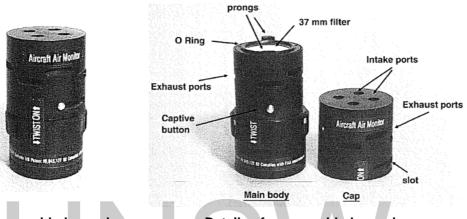
Figure 5-3: The VN Sampler

The assembled sampler

Details of unassembled sampler

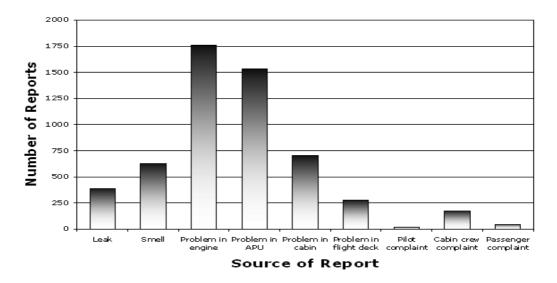
Figure 6-2: 1992 - 1994 Ansett Discrepancy Reports by source of problem

Additionally the records in Figure 6-2 show the source of the problem varied with most attributed to the engine (1762 reports) followed closely by the APU (1530 reports). Description and therefore the source of the events varied somewhat with overlap evident.

While contaminated air events predominantly related to oil leakage are well documented, a recent review of a previously unavailable database, involving fume events on Ansett Australia's BAe 146 fleet between 1992 and 1994 is of considerable interest. [173] The documents were obtained as part of legal proceedings in the courts, which enabled 3 folders (339 pages) of discrepancy reports, used by the airline-engineering department, to be reviewed. 3828 discrepancy reports were reviewed (1660 in 1992, 1093 in 1993 and 1075 in 1994). Figure 6-1 shows a sample of the discrepancy reports and Figure 6-2 shows an analysis of this data.

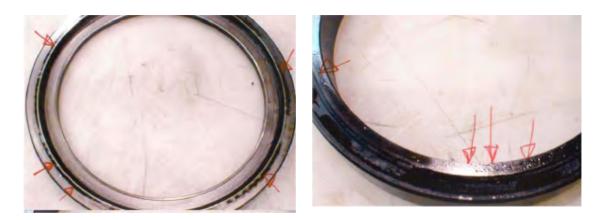
Figure 6-5: BFU report: 1800, BAe 146 RJ. 17 August, 1999: Oil seals

The Swiss Aircraft Accident Investigation Bureau has recently published 4 known key reports concerning aircraft contaminated air. A 1999 report refers to a 'serious incident' in which oil was identified as having leaked from bearing no. 2. A three engine ferry flight to the maintenance base was undertaken. [185] Oil residues in the air conditioning system were reported to be responsible for the toilet smoke alarm during the flight. Oil carbon deposits and surface wear were subsequently identified at the sealing surfaces of the no. 2 bearing, therefore no longer allowing complete sealing (refer Figure 6-6) that led to the oil leaks. The internal oil leak then mixed with the high pressure bleed air and passed into the cabin air via the high pressure compressor bleed port through to the air conditioning pack and then into the cabin air supply.

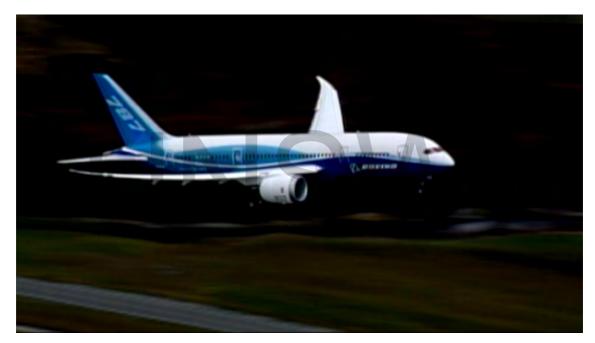
In 2004, Boeing advised that that the B7E7 (787) (Figure 7-1) bleed free engine selection was 'one step forward' in dealing with the contaminated air issue. [195] In 2007 Boeing stated 'the Boeing 787 will have a no-bleed architecture for the outside air supply to the cabin. This architecture eliminates the risk of engine oil decomposition products from being introduced in the cabin supply air.' [196]

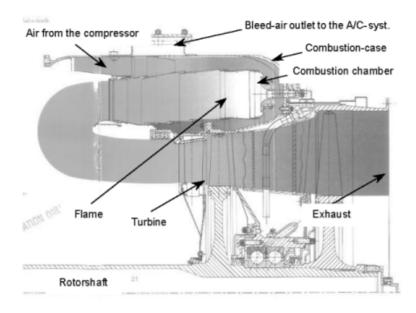
Figure 7-3: BAe 146 ALF 502/507 - Burner section

Burner section

The combustion case and combustion chamber are designed so that air that is bled off for the air conditioning system shall not be able to contain any combustion gases or air that has been in contact with hot surfaces in the combustion case. However, ingestion of oil mist or overheated oil product into the air conditioning system is possible and secondly, the *'bleed-air outlet is located very close to the combustion chamber.'* [116] Additionally as the air is taken from output of the HP compressor only, this is the point at which temperatures in the compressor are at the maximum.

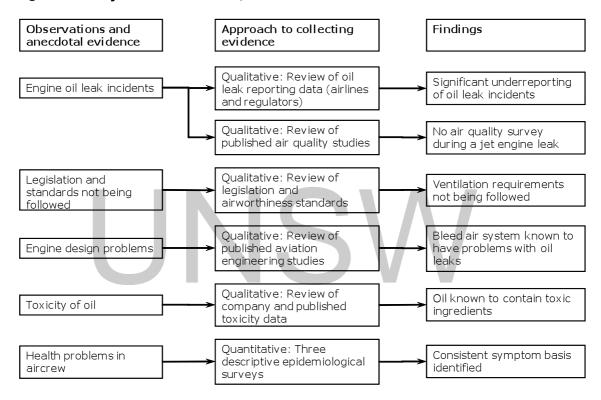
Figure 8-1 below demonstrates the key mixed methods approach used in this thesis and upon review indicates that the use of both qualitative and quantitative data serves the purpose of reviewing the various aspects of the contaminated air issue and therefore the true scale of the problem. The qualitative data has been collated data to support or refute the theory that contaminated air is a significant problem.
