Health and Flight Safety Implications from Exposure to Contaminated Air in Aircraft

A thesis submitted in fulfilment of the requirements for
the degree of Master of Doctor of Philosophy
School of Risk and Safety Sciences
Faculty of Science
The University of New South Wales

September 2010

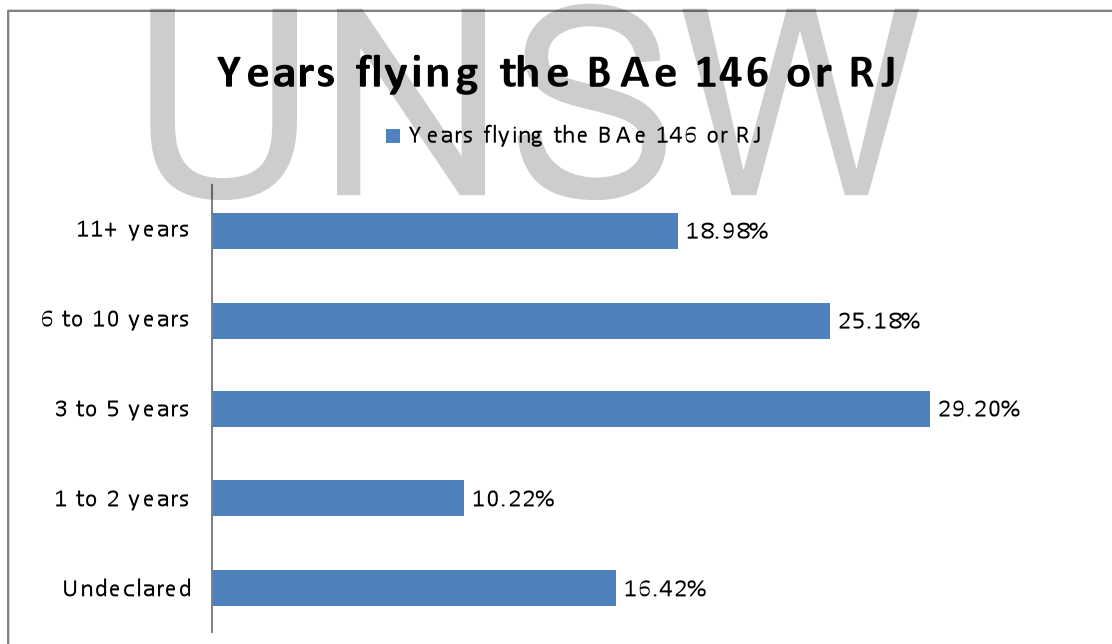
Figure 4-7: Years flying on the BAe 146 or 146 RJ

The length of total flying experience was often given but not consistently recorded, so it was not tabulated. However, it was often significant.

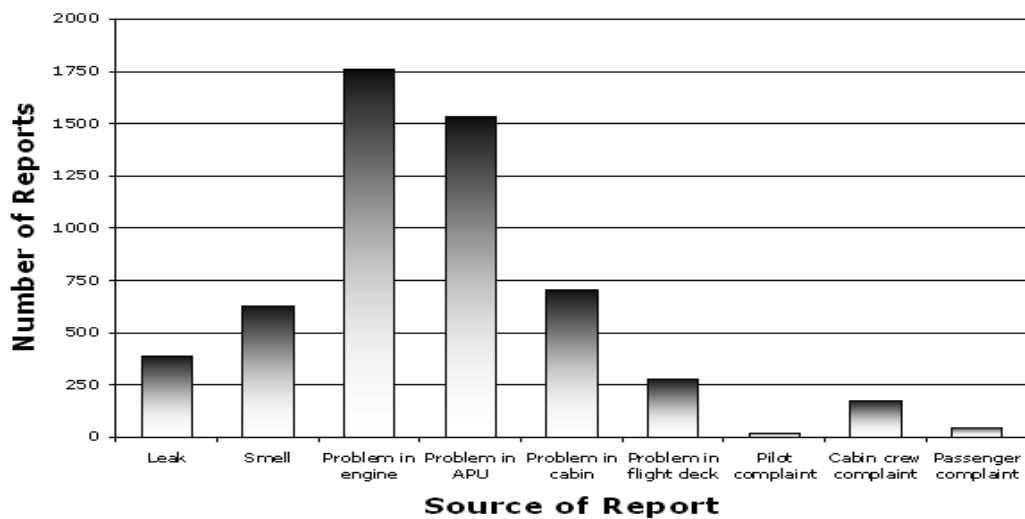
Figure 6-2: 1992 - 1994 Ansett Discrepancy Reports by source of problem

Additionally the records in Figure 6-2 show the source of the problem varied with most attributed to the engine (1762 reports) followed closely by the APU (1530 reports). Description and therefore the source of the events varied somewhat with overlap evident.

While contaminated air events predominantly related to oil leakage are well documented, a recent review of a previously unavailable database, involving fume events on Ansett Australia's BAe 146 fleet between 1992 and 1994 is of considerable interest. [173] The documents were obtained as part of legal proceedings in the courts, which enabled 3 folders (339 pages) of discrepancy reports, used by the airline-engineering department, to be reviewed. 3828 discrepancy reports were reviewed (1660 in 1992, 1093 in 1993 and 1075 in 1994). Figure 6-1 shows a sample of the discrepancy reports and Figure 6-2 shows an analysis of this data.

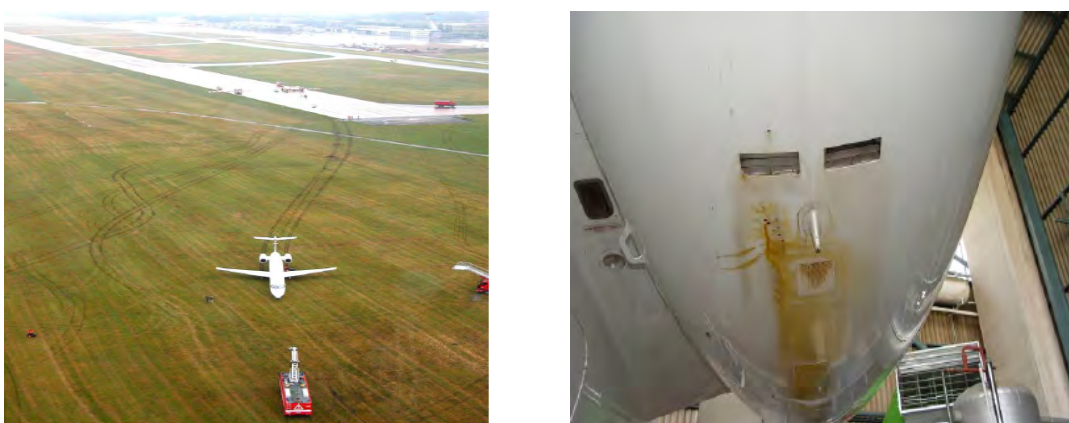
Figure 6-6: BFU report: 5X008-0/06, Embraer 145. 28 June 2006

One other smoke/contaminated air event listed involved an Embraer 145 (BFU 5X008-0/06) as shown in Figure 6-6 departing the runway after landing with visibility due to smoke reduced to 20cm and subsequent engine inspection. The

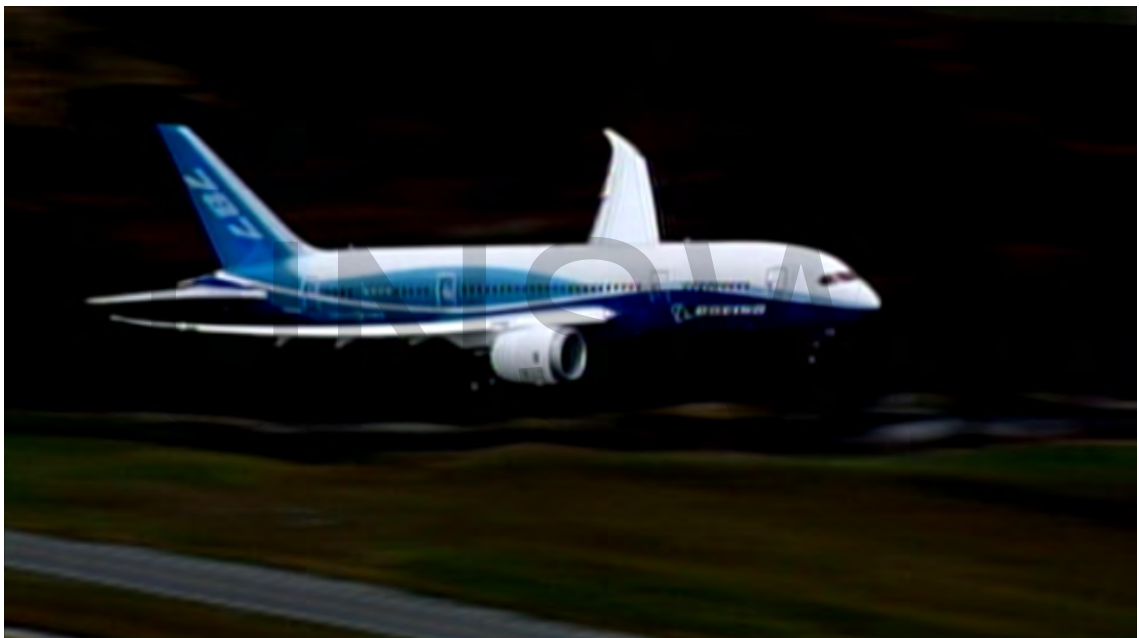
Figure 7-1: Boeing 787

In 2004, Boeing advised that that the B7E7 (787) (Figure 7-1) bleed free engine selection was *'one step forward'* in dealing with the contaminated air issue. [195] In 2007 Boeing stated *'the Boeing 787 will have a no-bleed architecture for the outside air supply to the cabin. This architecture eliminates the risk of engine oil decomposition products from being introduced in the cabin supply air.'* [196]
